THE EXTENT OF THE PROBLEM OF EARTHEN BUILDINGS
IN GREECE

Panayotis Gr. Carydis

ABSTRACT

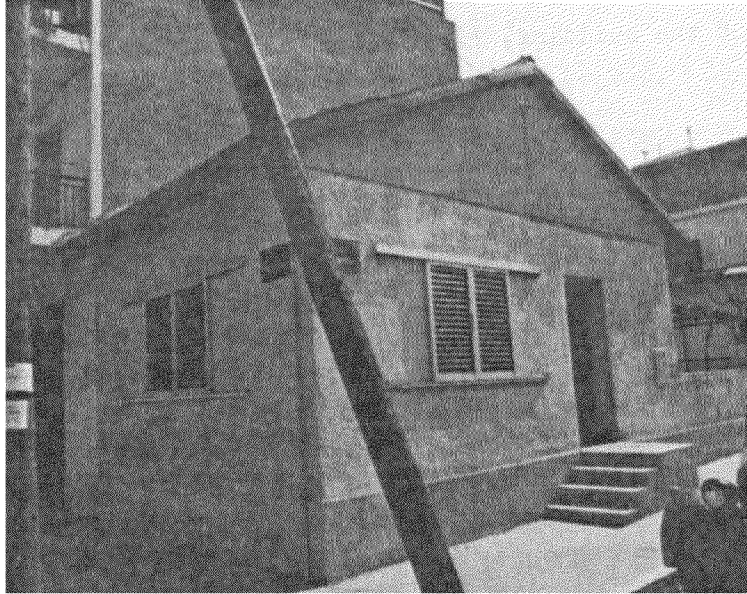
FIG. 4

All the well maintained buildings out of wood frame and earthen raw bricks in Kiation withstood the various earthquakes quite well, Fig. 4. If we assume a rather strong shock every 20 +25 years that happens in this region, this type of buildings has been tested by the earthquakes two to three times quite successfully.

Well maintained earthen buildings stand the test of time and of earthquakes very well.

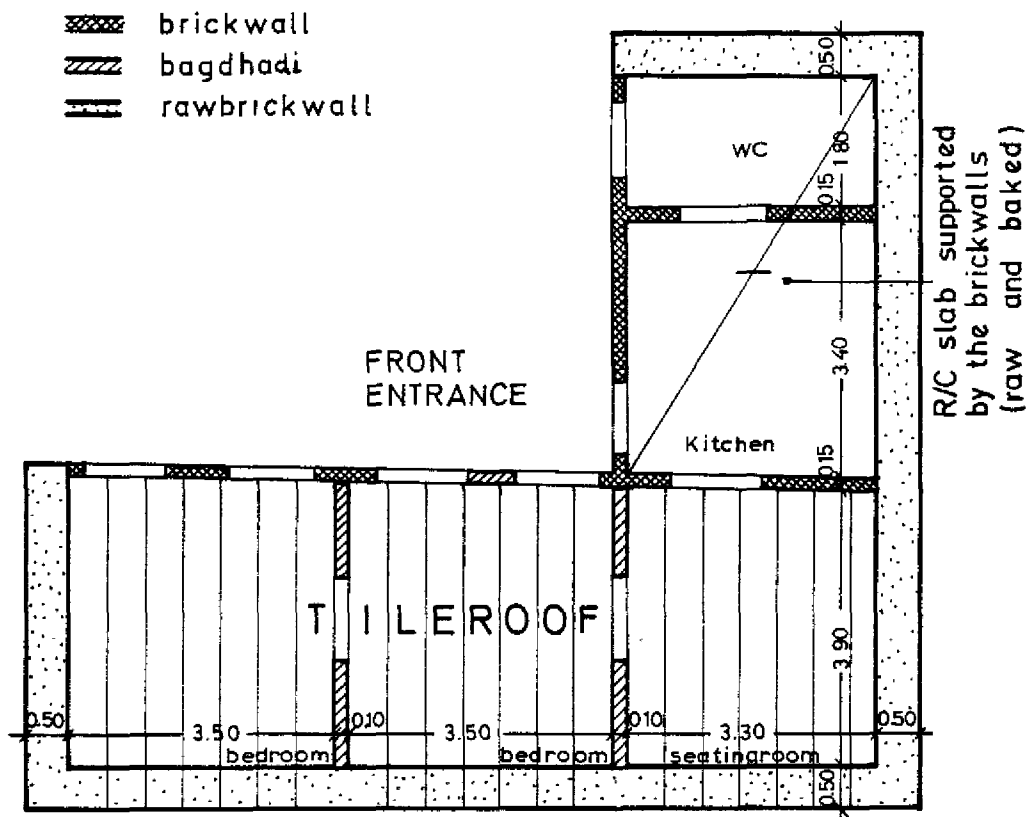
FIG. 7

One storied Earthen building since 1900, with new facade and partially new roof out of R/C, in Aghios Ioannis Rentis/Athens.

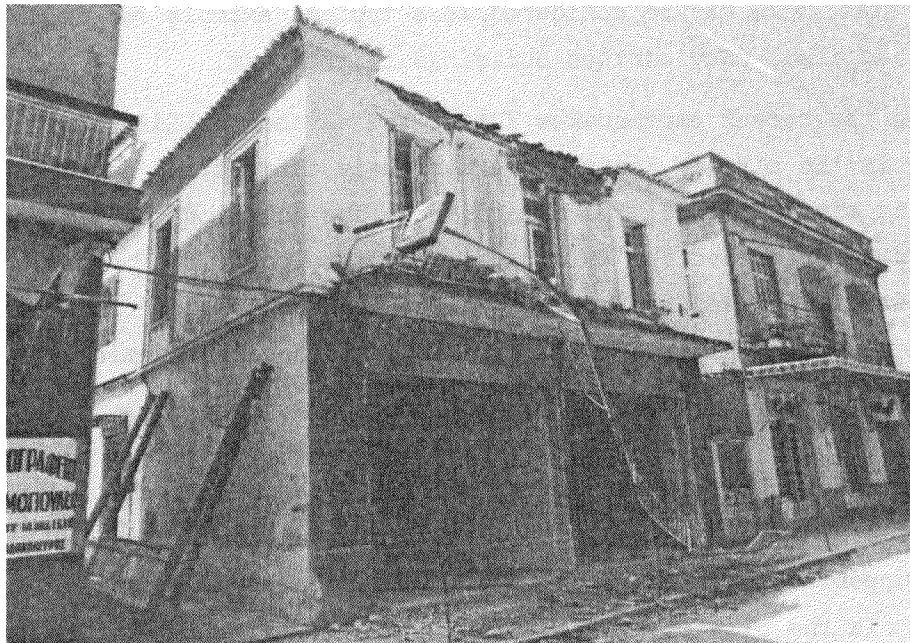
FIG. 8

Two storied earthen building in the center of the city of Kiaton. In the front of the first storey, a R/C construction replaces the existing wall: beam with balcony on slender columns. The building was seriously damaged by the recent earthquakes.

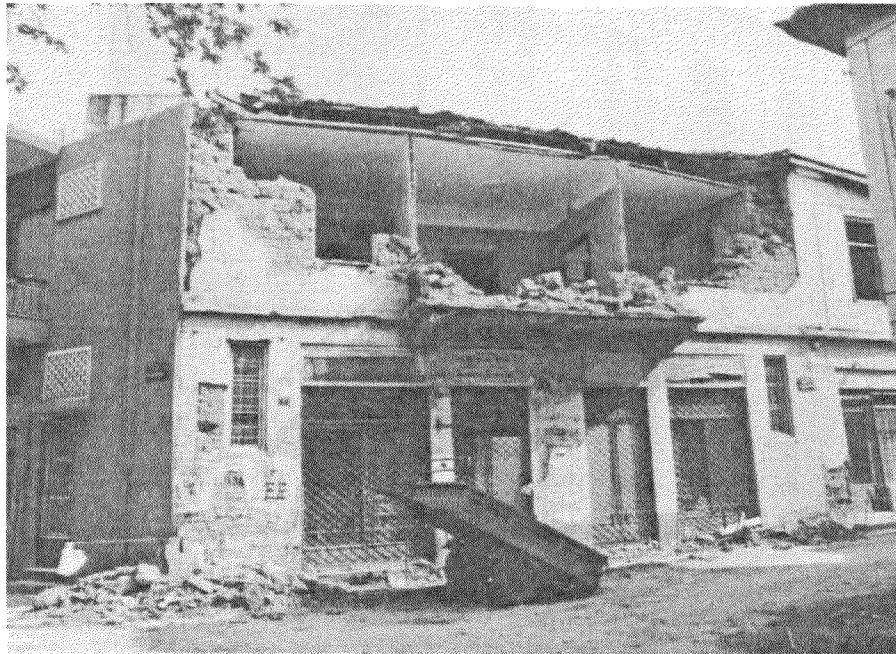
FIG. 9

Two storied earthen building in the center of the city of Kiaton. Details of the construction of the roof and of the light partitions. Alterations in the front of the first storey.

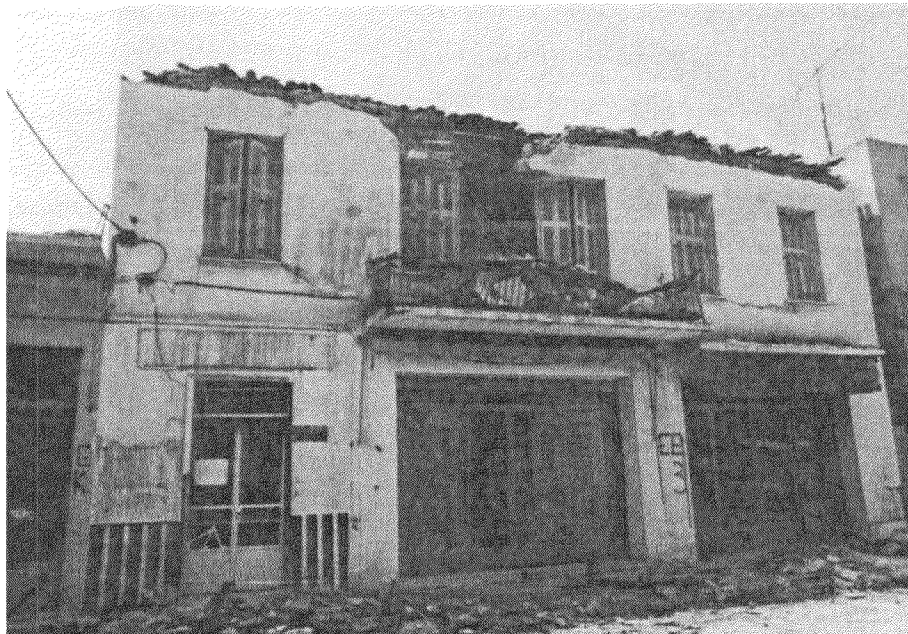
FIG. 10

Two storied earthen building in the center of the city of Kiaton. Beam on columns out of R/C replaces the biggest part of the front wall of the first storey, for larger openings for the windows.

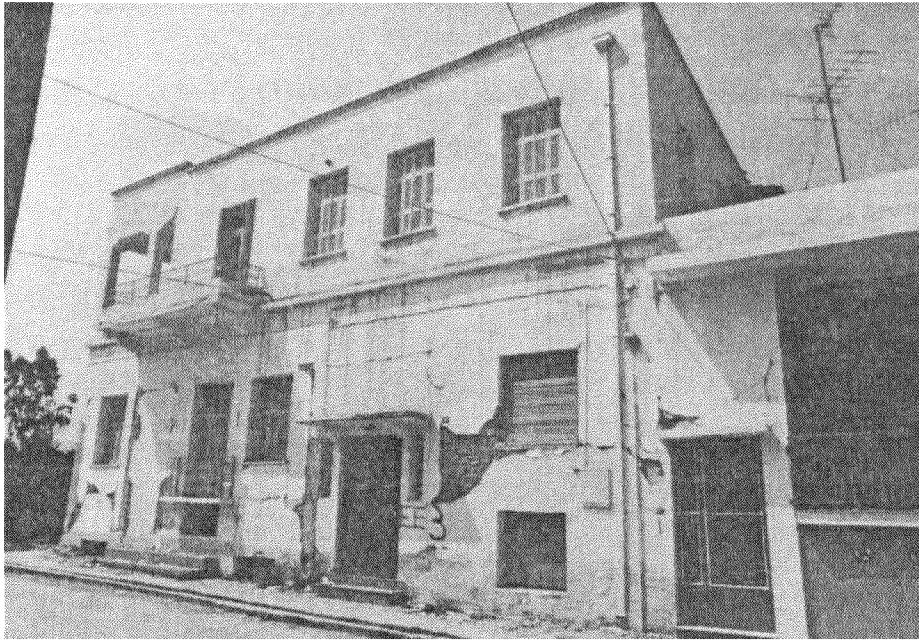
FIG. 11

An one storey old earthen building has been renovated with the addition of R/C columns and R/C beams, and of a second storey, out of R/C load carrying system and baked brick walls for partitions.

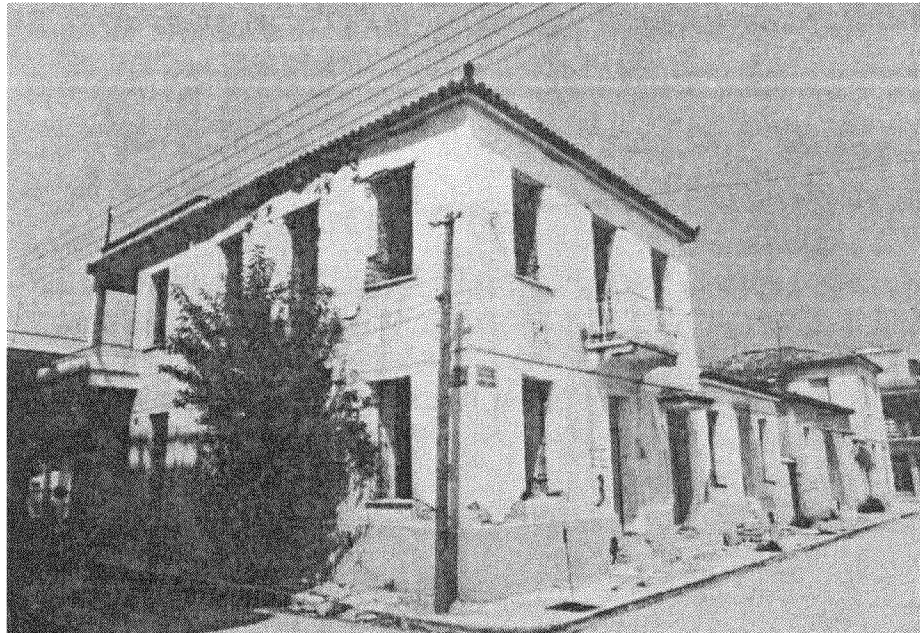
FIG. 12

A modern construction out of R/C and baked brick walls is added to an old two storied earthen building.

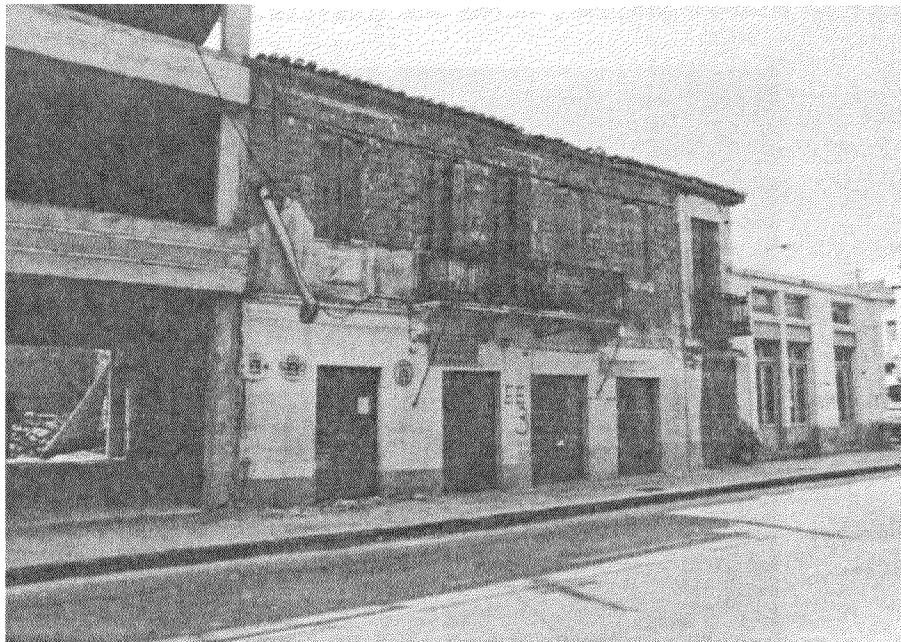
FIG. 13

In Fig. 12 through 14 other damages of two storied earthen buildings are shown after the recent earthquakes in the city of Kiaton. These buildings have suffered several strong earthquakes. Most of them have not been repaired during the last 50 years.

Old earthen building near the sea shore. The separation of the mortar is typical.

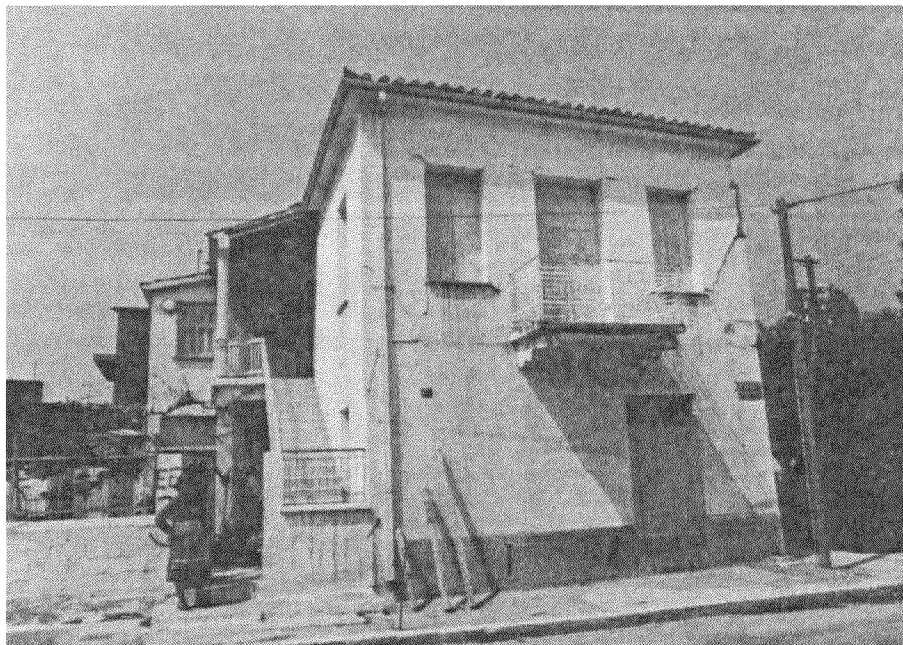
FIG. 14

A two storied earthen building, 100 years old. This building has suffered at least 3 strong earthquakes, while it was not repaired after the second one.

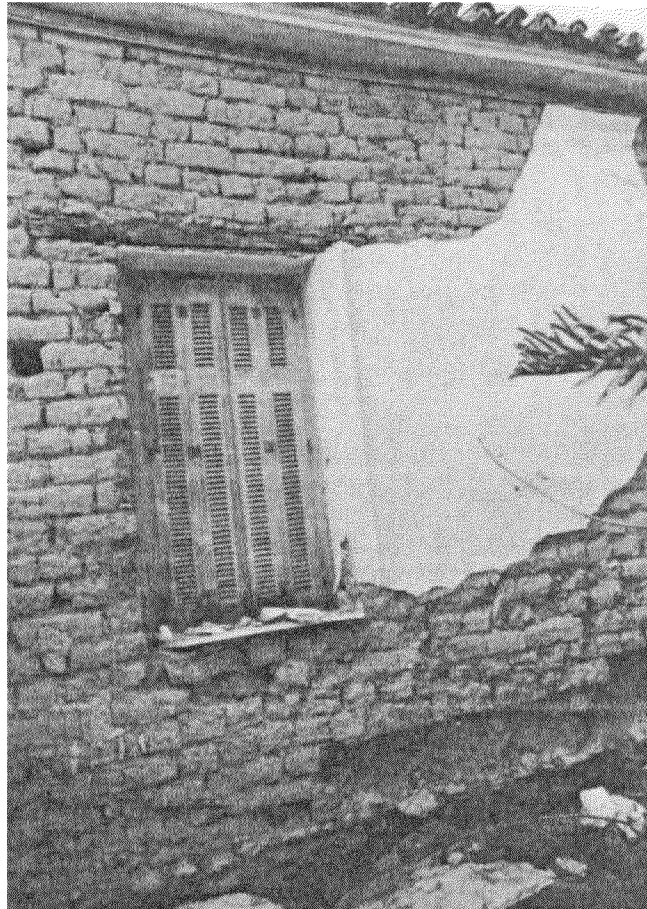
FIG. 15

The rain water, the ground water or the humidity are destructive for the raw bricks. For this reason a waterproofing mortar is one of the best means to make the earthen buildings more durable.

The wooden beams which are put for strengthening the walls of earthen buildings are vulnerable to microorganisms, worms and insects.

Humidity and ground water is coming from the body of the foundation. The uncovered raw bricks loose their strength. The wooden beams of the lintel and roof have been moth-eaten.

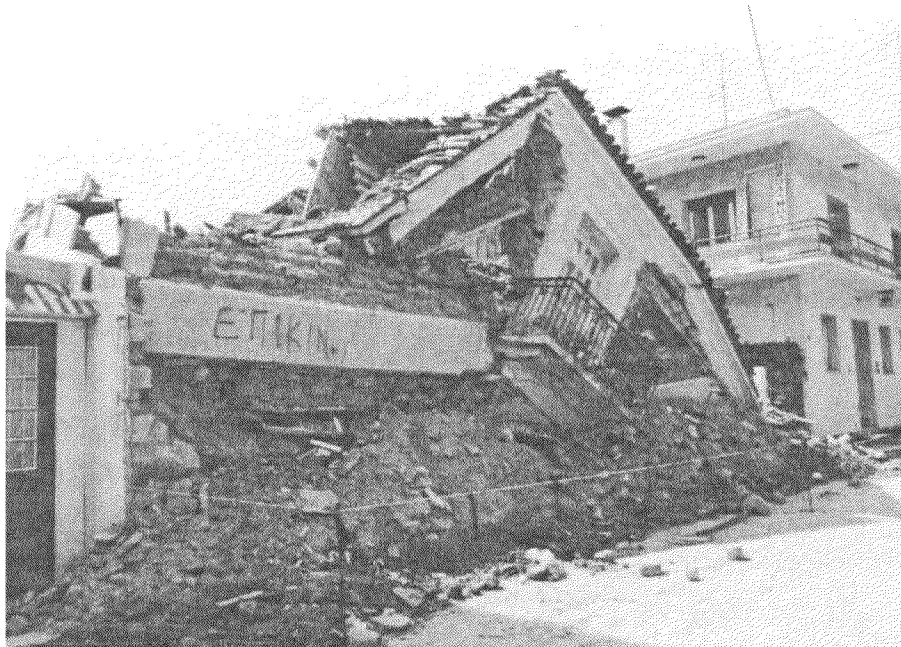
FIG. 16

It is interesting to notice here that many earthen buildings collapsed slowly. The remaining parts did not move one in relation to the other, which means that during the collapse of the building there was no shock or any high acceleration of the particular parts. Some observers say that the buildings sat slowly on the ground.

Collapsed two - storied earthen building
