# International Workshop Earthen Buildings in Seismic Areas

**INTERNATIONAL WORKSHOP  
EARTHEN BUILDINGS IN SEISMIC AREAS**

THE EXTENT OF THE PROBLEM OF EARTHEN BUILDINGS

IN GREECE

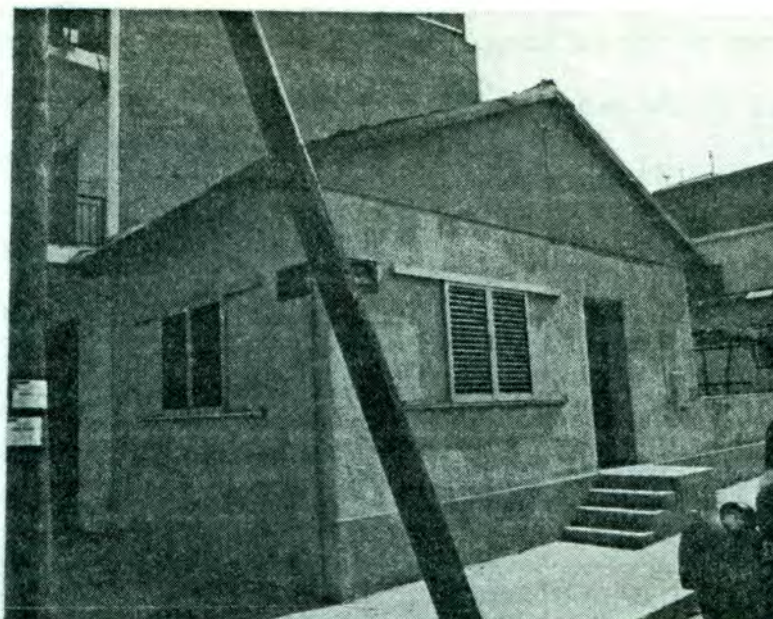
FIG. 4

All the well maintained buildings out of wood frame and earthen raw bricks in Kiation withstood the various earthquakes quite well, Fig. 4. If we assume a rather strong shock every 20 +25 years that happens in this region, this type of buildings has been tested by the earthquakes two to three times quite successfully.

Well maintained earthen buildings stand the test of time and of earthquakes very well.

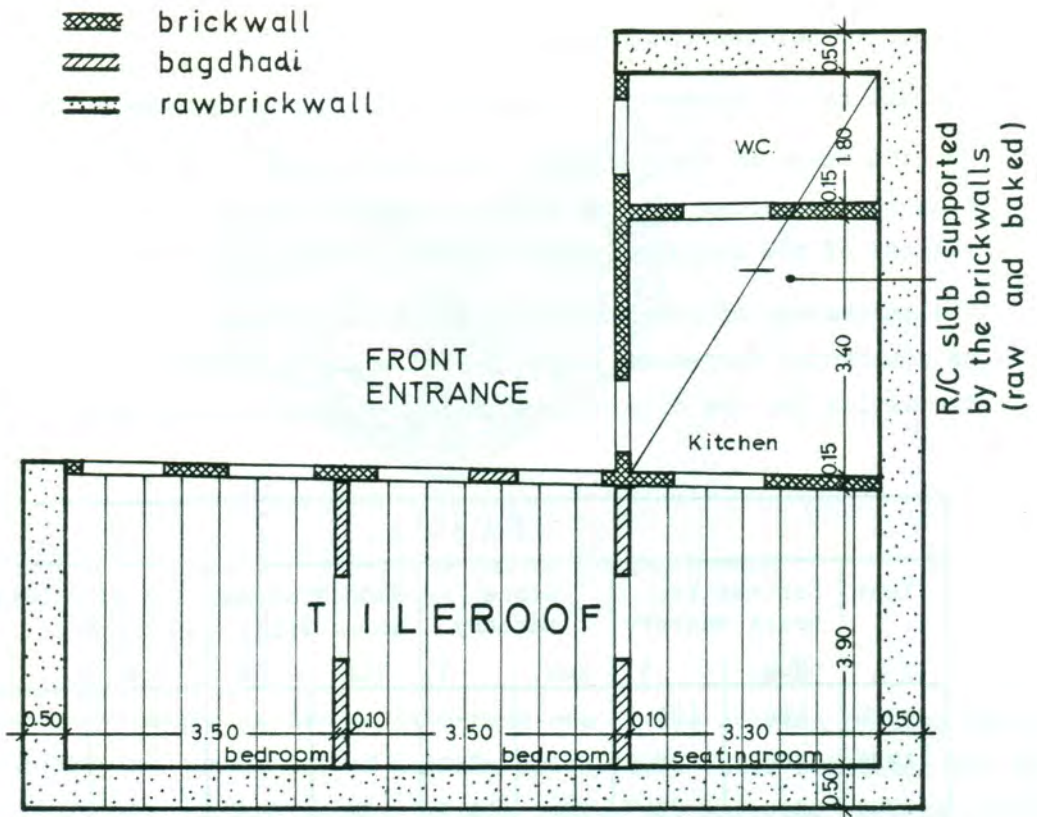
FIG. 7

One storied Earthen building since 1900, with new facade and partially new roof out of R/C, in Aghios Ioannis Rentis/Athens.

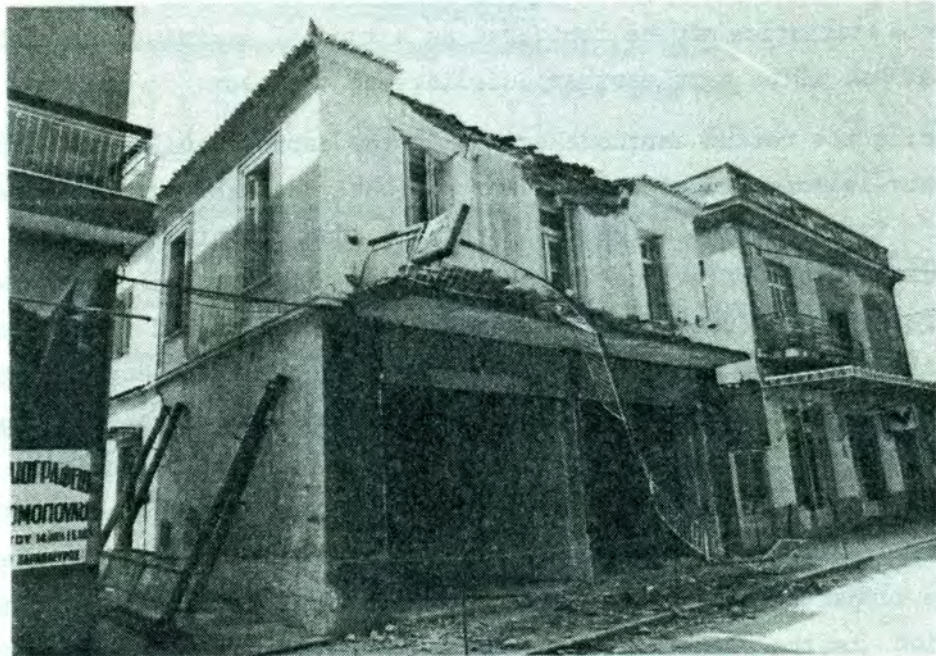
FIG. 8

Two storied earthen building in the center of the city of Kiaton. In the front of the first storey, a R/C construction replaces the existing wall: beam with balcony on slender columns. The building was seriously damaged by the recent earthquakes.

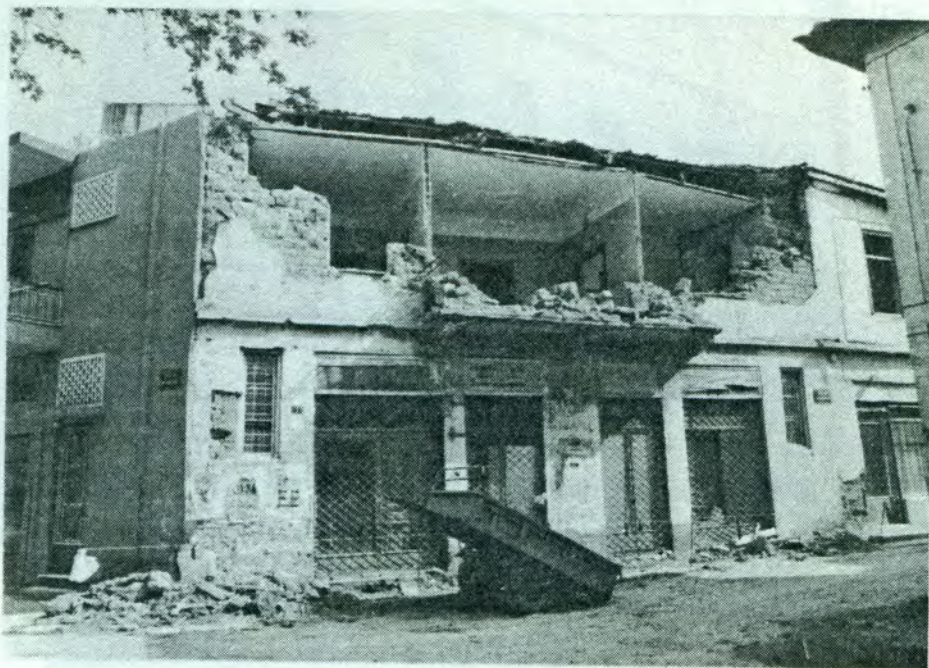
FIG. 9

Two storied earthen building in the center of the city of Kiaton. Details of the construction of the roof and of the light partitions. Alterations in the front of the first storey.

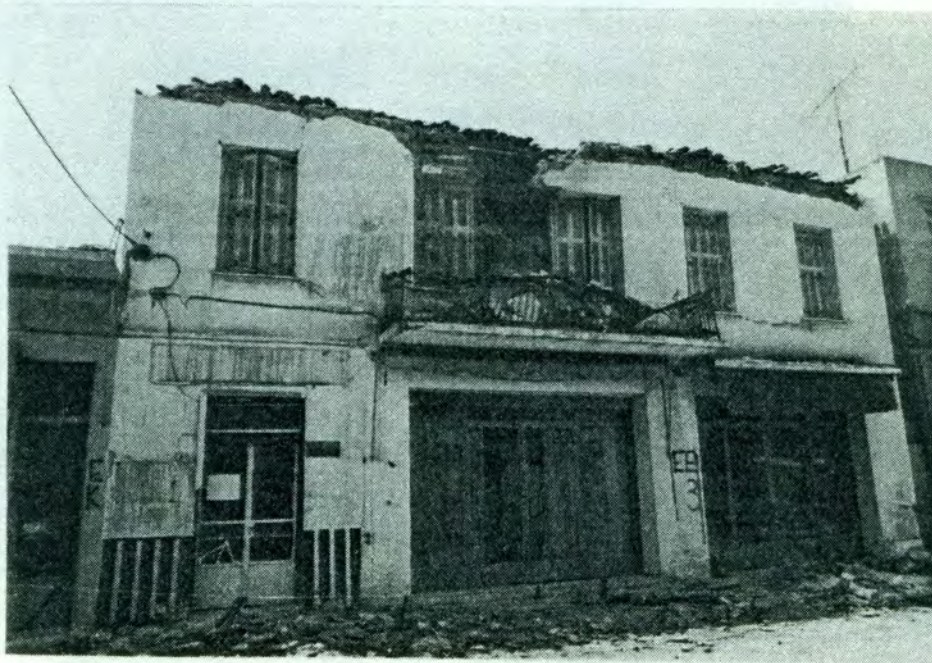
FIG. 10

Two storied earthen building in the center of the city of Kiaton. Beam on columns out of R/C replaces the biggest part of the front wall of the first storey, for larger openings for the windows.

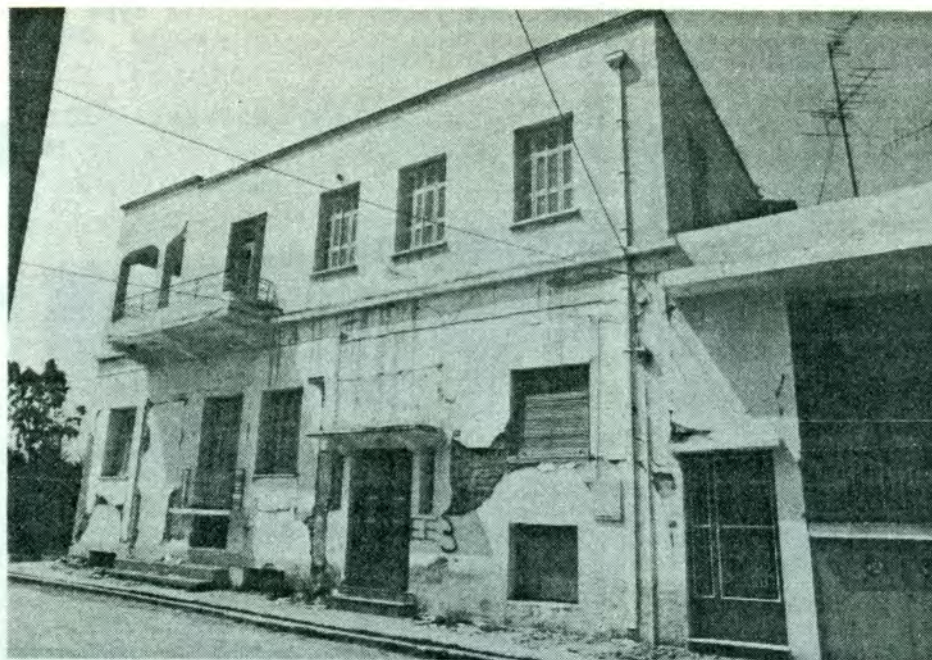
FIG. 11

An one storey old earthen building has been renovated with the addition of R/C columns and R/C beams, and of a second storey, out of R/C load carrying system and baked brick walls for partitions.

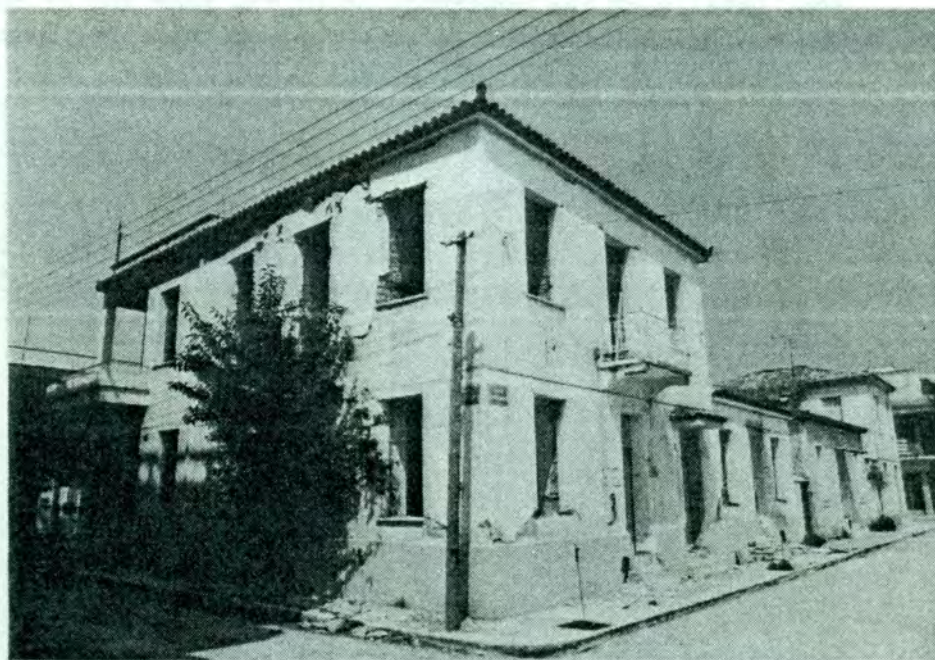
FIG. 12

A modern construction out of R/C and baked brick walls is added to an old two storied earthen building.

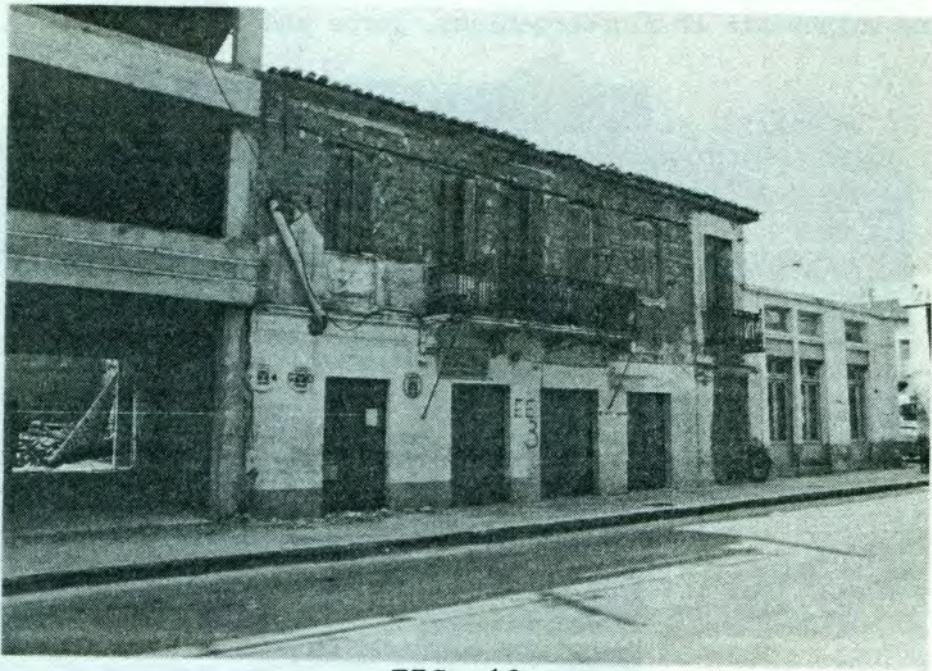
FIG. 13

Old earthen building near the sea shore. The separation of the mortar is typical.

The rain water, the ground water or the humidity are destructive for the raw bricks. For this reason a waterproofing mortar is one of the best means to make the earthen buildings more durable.

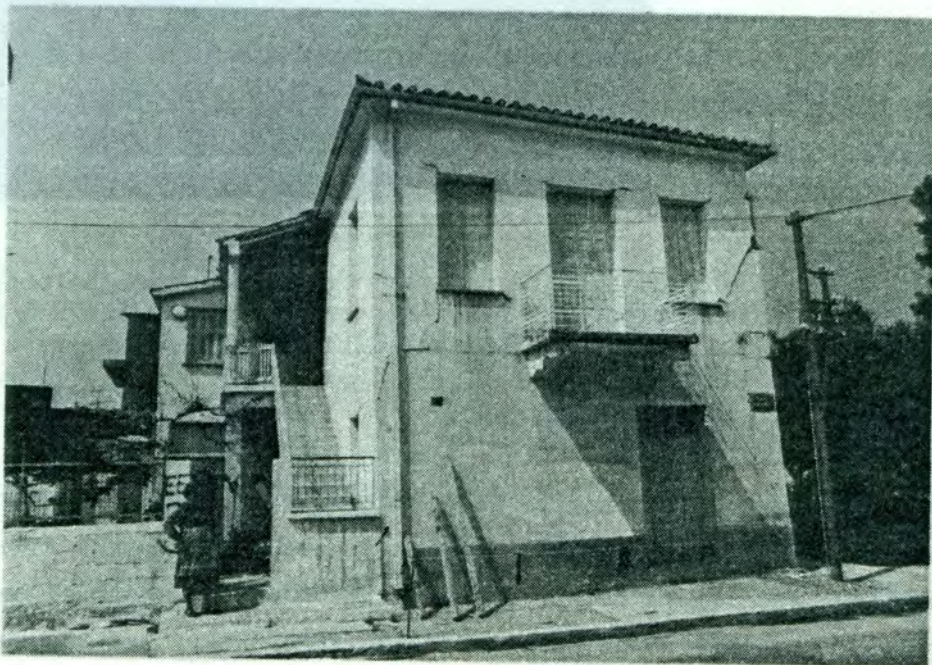
FIG. 14

A two storied earthen building, 100 years old. This building has suffered at least 3 strong earthquakes, while it was not repaired after the second one.

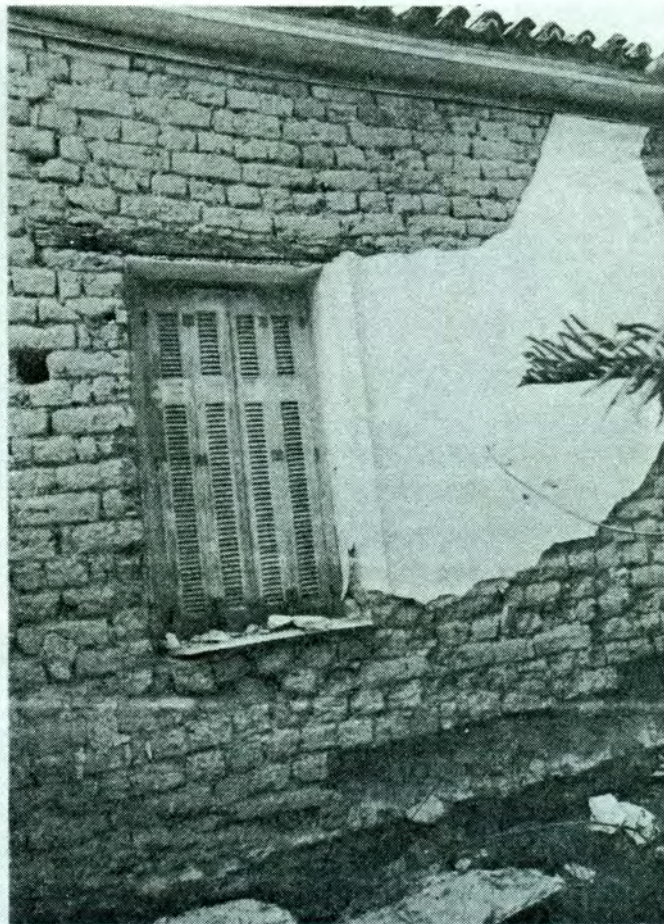
FIG. 15

The wooden beams which are put for strengthening the walls of earthen buildings are vulnerable to microorganisms, worms and insects.

Humidity and ground water is coming from the body of the foundation. The uncovered raw bricks loose their strength. The wooden beams of the lintel and roof have been moth-eaten.

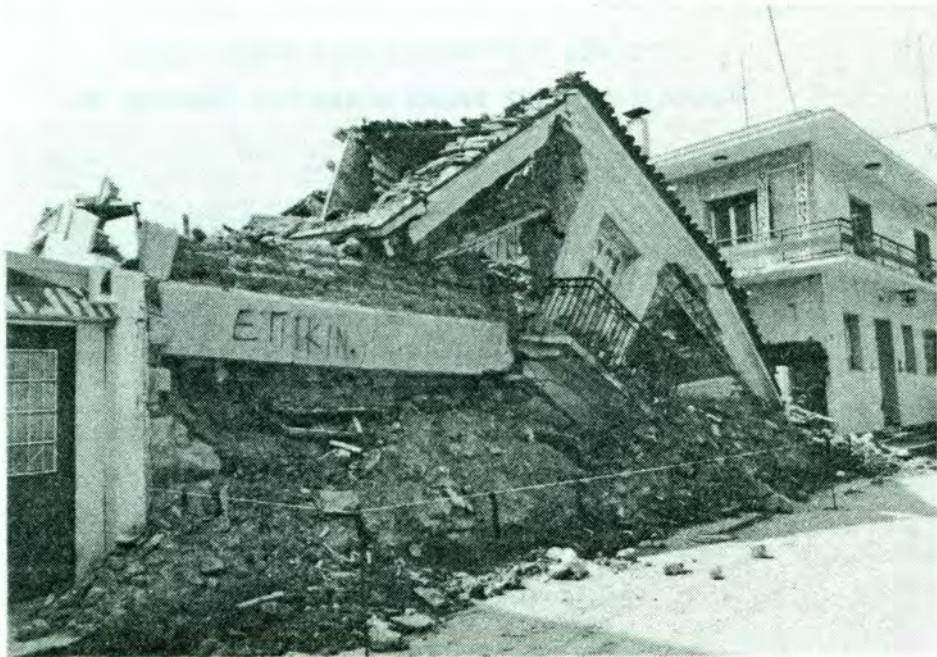
FIG. 16

It is interesting to notice here that many earthen buildings collapsed slowly. The remaining parts did not move one in relation to the other, which means that during the collapse of the building there was no shock or any high acceleration of the particular parts. Some observers say that the buildings sat slowly on the ground.

Collapsed two - storied earthen building
