Learning from Earthquakes

Preliminary Observations on the August 14, 2003, Lefkada Island (Western Greece) Earthquake

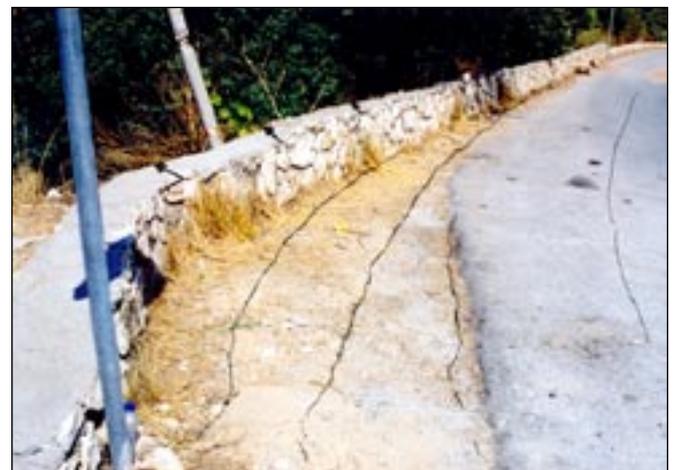
Figure 9. Many retaining walls leaned towards the external side; the adjacent parts of the roads subsided, and cracks appeared on the pavement (NTUA-UoA team).

The length of the fissures varied from a few tens of cm to tens of m, their width was from a few mm to 10 cm, and their visible depth reached 30 cm. A systematic study of the trends of the fissures showed that there were two prevailing sets, one parallel to the coast and one normal to it. In addition, the pattern was similar at the cracks located in the river deposits; however, the primary set ran parallel to the riverbed and the secondary ran normal to it. The fissures and cracks had no genetic relationship with the fault deformation, but they were a by-product of the seismic movement. Their occurrence is exclusively controlled by the differential compaction of the loose formations, the lateral instability of the ground masses at the coastal or riverside area, and the

differential seismic response of the various unconsolidated phases of the formations (figures 9 and 10). Most of them are also connected to liquefaction phenomena and represent lateral spreads and extensional failures.

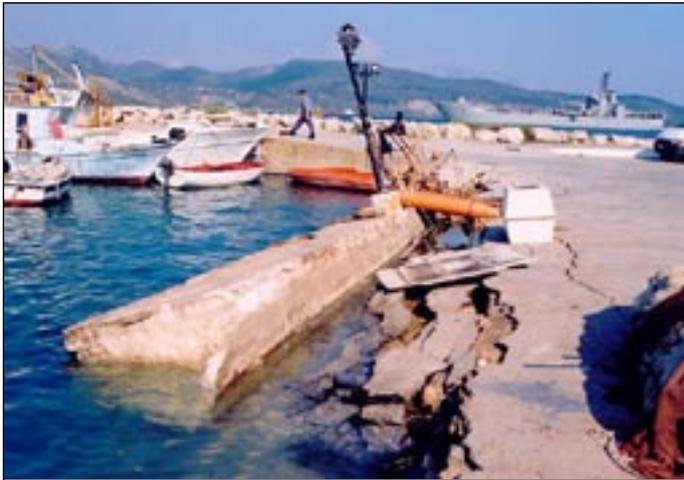
Figure 10. Ground subsidence of the fill material of about 30 cm (NTUA-UoA team).

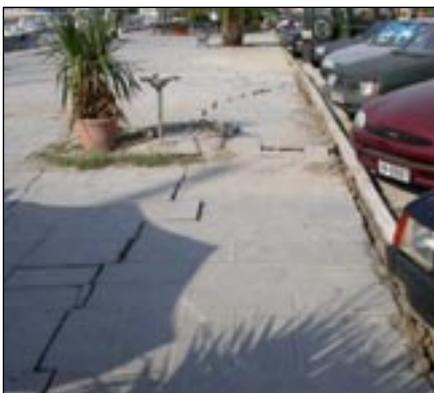
In the town of Lefkada, damage included uplifted, sunken or cracked concrete slabs, and distorted pavement and sidewalks (figure 11). Shallow subsurface materials at these sites probably consisted of uncompacted, miscellaneous fill. Local residents reported that muddy water was ejected from cracks in pavement surfaces. Observed ground cracking with lateral spreading, as well as silty-sandy boils along the waterfront in the town of Lefkada and in Nydri village, were the primary surface evidences of liquefaction, indicating high excess pore pressure generation during earthquake shaking.

Figure 11. In the town of Lefkada, distorted pavement and sidewalks due to ground settlement and lateral spread (ITSAK team).

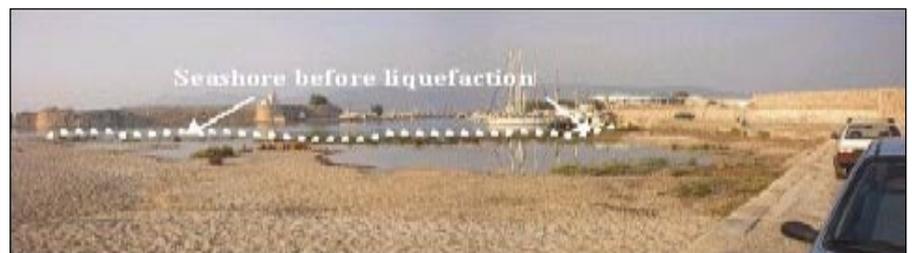
Figure 12. Area near the castle of Lefkada where soil liquefaction, lateral spreading, and ground settlement occurred (ITSAK team).

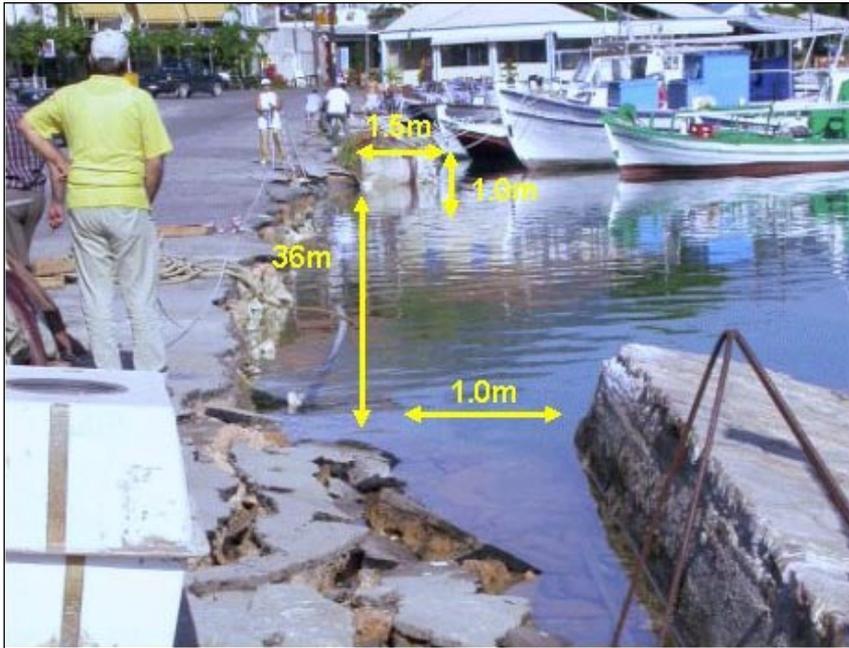
Densification of loose surface soil layers and of poorly compacted fills behind seawall facilities caused settlements and lateral spreading towards the free face. The horizontal and vertical displacements varied between sites, but they were in the range of 10-25 cm. Figure 13 shows ground settlement near the coastline. Lateral spreading was prevented due to the seawall, but an up-lift of the ground just behind the seawall tilted the lampposts.

Figure 13. Part of the seawall has been laterally shifted and overturned (ITSAK team).

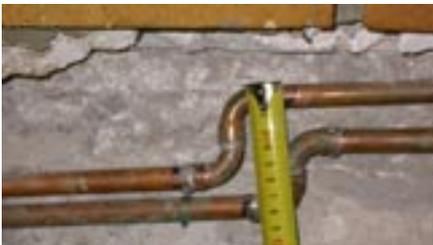
area, observed damage indicates a differential settlement between adjacent buildings of 5-10 cm. However, those buildings did not suffer any severe damage due to their relatively small mass, their “flexible” wooden frame, and, in cases of RC structures, their foundation type (mat foundation, tie or foundation beams). Figure 14 shows a plan view of two adjacent buildings with a common pipeline system that had a differential settlement of about 5 cm.

Figure 14. Plan view of two adjacent buildings with a common pipeline system that had a differential settlement of about 5 cm (ITSAK team). (Photo taken after repairing.)

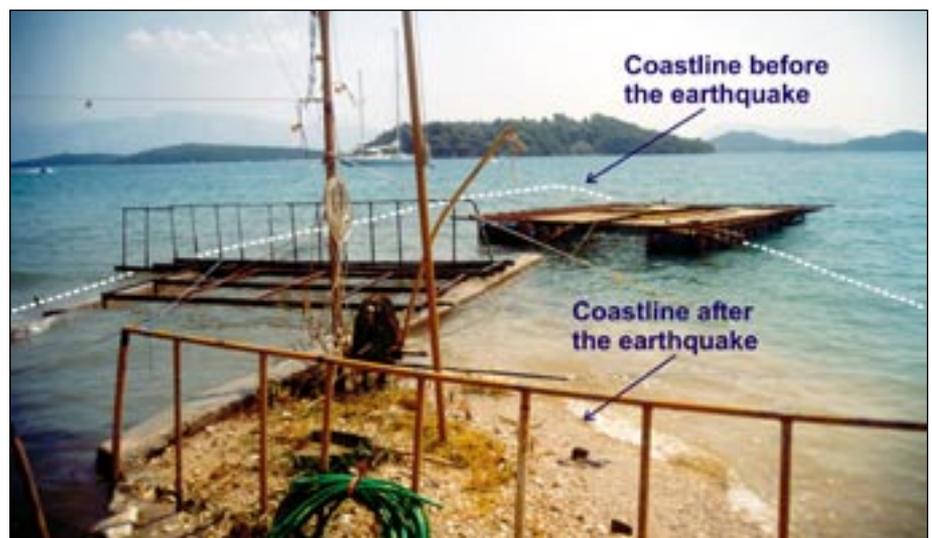
Nydri, at the river mouth of the Aspropotamos torrent. The coastline retreat of 1 m to 20 m damaged some minor human construction and tourist and beach sport facilities. The most striking change took place at the coast of Kambos, where the sea progressed inland for about 20 m, covering an area more than 50 m wide. The coastline changes were due to (1) rearrangement of the packing in the Holocene formations

(mainly sands, gravel, and cobbles with silt and clay intercalations) because of seismic shaking, (2) small-scale submarine landslides with simultaneous loss of lateral support, or (3) liquefaction.

Figure 15. Coastline changes at Nydri beach (NTUA-UoA team).

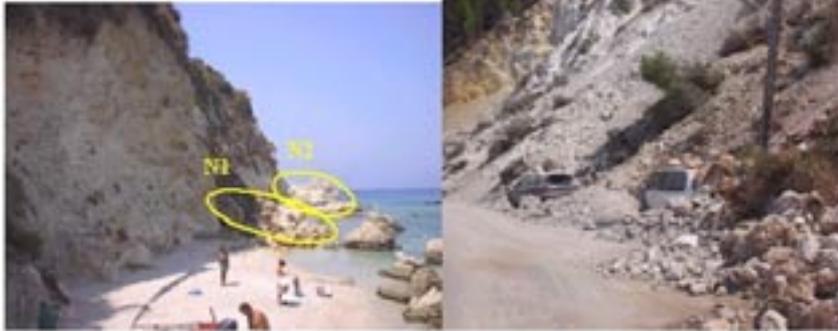
Figure 16. Rockfalls due to detachment and possible overturn at the Agios Nikitas (left); Cars were buried under landslides near the same beach (right) (ITSAK team).

schists) located on steep cut slopes (horizontal:vertical = 2:1 to 3:1) and with heights ranging from 20 to 50 m, without any trench or other preventive countermeasures. There were also a considerable number of failures of embankment slopes, especially when lack of compaction was obvious.

swimming and sunbathing, but they did not cause any casualties, thanks to the early morning hour of the main shock. Figure 16 shows rockfalls and scree deposits due to overturn, detachment, and sliding at Agios Nikitas Beach.

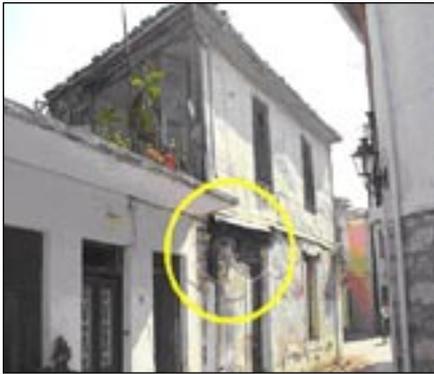
Figure 18. Partial collapse of masonry wall in a category B building (ITSAK team).

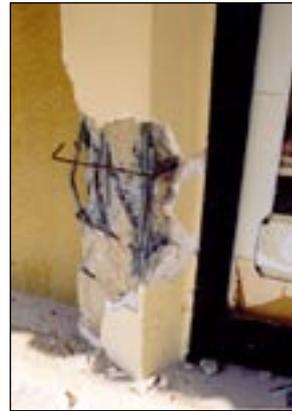
20a

In a building with a market and mezzanine on the ground floor: insufficient stirrups with poor detailing (a).

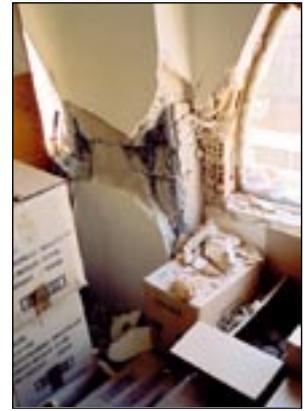
20b

In the mezzanine: damaged columns on the surface between phases of concrete and the lower part of the arches, formed with brickwalls (b) (NTUA-UoA team).

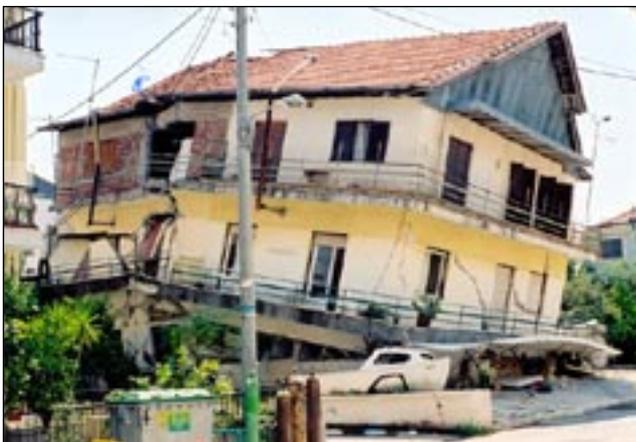
Figure 19. Collapse of R/C building in the town of Lefkada. On the right side, there are no brickwalls on the ground floor, where the building collapsed. The remaining part on the left side has partitions down to the foundation (NTUA-UoA team).

A total collapse occurred in a three-story R/C building (category C) with short columns on the ground floor at the front and thick brick infill walls at the back. The building was poorly designed with inadequate stirrups at the columns (figure 19).

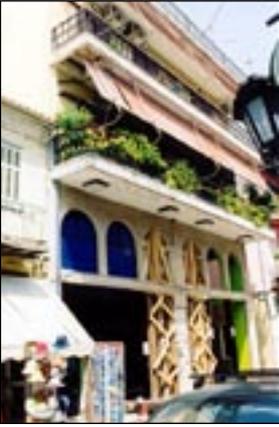
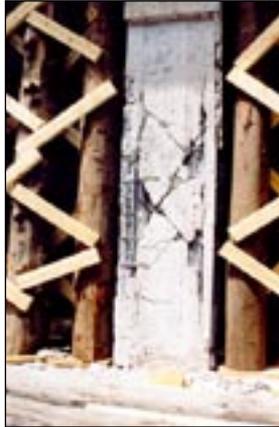
Figures 21a and b. A four-story building with a mezzanine was heavily damaged in the ground floor columns. The columns seem to have swollen in the center due to insufficient transverse reinforcement (NTUA-UoA team).

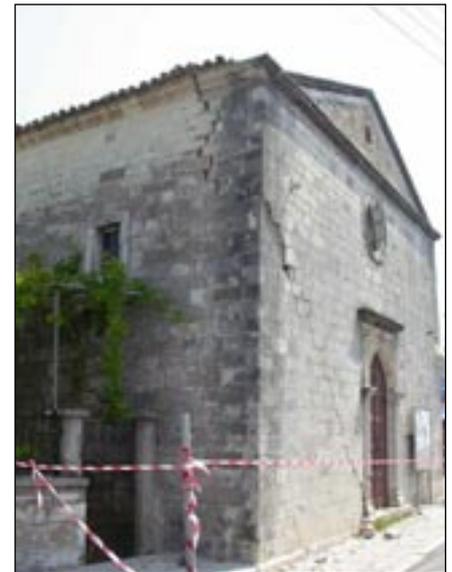
Figure 23. Cracking of masonry walls of Agios Minas church (town of Lefkada) (ITSACK team).

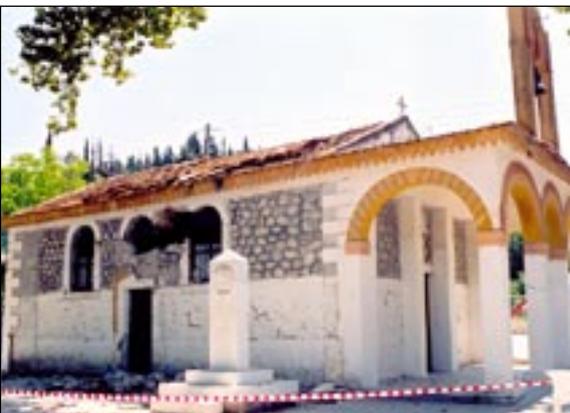
Figure 22. Churches built of stone masonry suffered heavy damage. In various parts of Lefkada, the tiles at the center of roofs moved. This might be explained by the vertical flexibility of the roof at its center (NTUA-UoA team).
