# *EUROPEAN EARTHQUAKE ENGINEERING*

# Influence of the vertical component on damage during shallow-nearfield earthquakes

D. Benedetti\*, P. Carydis\*\*

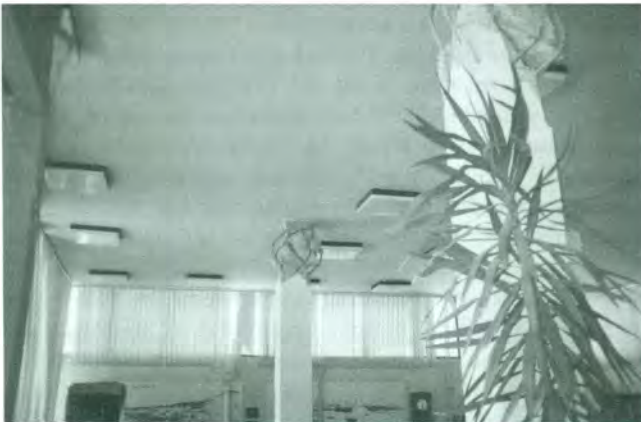
and well designed r.c. structure suffered damage beyond the limit of repair in columns at the ground level. Damage occurred mainly at the top of these columns (Figs. 1a and 1b). It may be explained by considering the effect of the vertical component, due to which the vertically travelling P-waves in the columns are engaged under the rather massive slab at their top. Note that in the figure glasses appear undamaged, thus suggesting rather low horizontal actions on the building, while the buckling of the reinforcement indicates significant vertical actions.

1a – Eagio (1996) earthquake. The crushing of concrete and the symmetrical buckling of bars are apparent. The vertical edges of columns are still aligned.

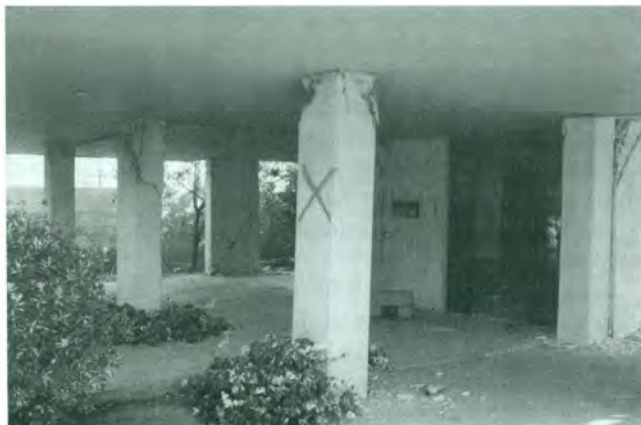
b) The type of damage above mentioned was observed very frequently after the 1999 Athens earthquake. A typical situation is depicted in figs. 2a and 2b. The first one shows damage at interior ground floor columns of a modern r.c. buildings, whose reinforcement buckled. There is a very modest evidence of lateral displacement and the important vertical actions on them cannot be attributed, due to the internal plan locations of the columns, to the effect of the overturning moment. Again, a reasonable interpretation of the damage calls for the effect of the vertical motion. To this respect, fig. 2b shows unbroken glasses at the entrance of the building, what suggest limited horizontal actions. The same damage pattern holds for other 5 buildings of

2a – Athens (1999) earthquake. Interior columns of a modern r.c. building. There is a poor evidence of lateral motion.

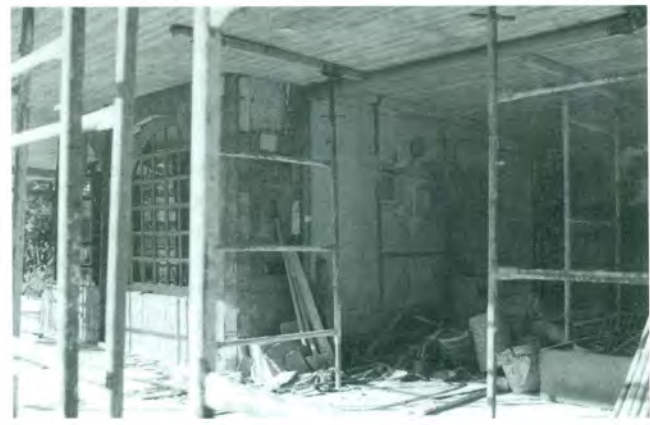
2b – Athens (1999) earthquake. Damage at the ground floor. Glasses are intact.

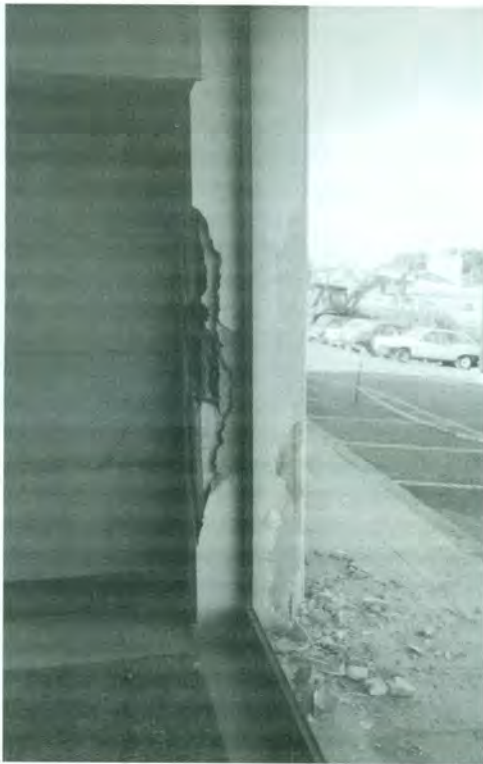
3a – Athens (1999) earthquake. Damage at midheight of columns.

c) Another typical damage that was observed after the same earthquake is shown in figs. 3a and 3b. Damage occurred at midheight of the columns, while no

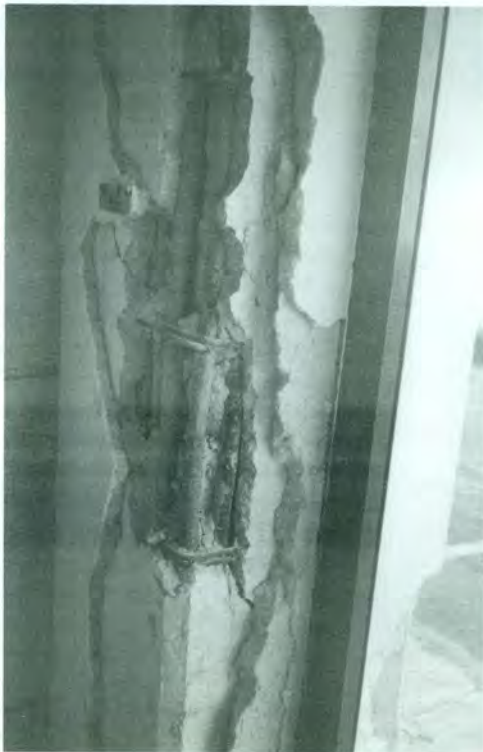
3b – Athens (1999) earthquake. Details of damage at midheight of columns, bars buckled.

cracks are detected at their top and bottom, as it would be the case for significant horizontal actions. Fig. 3b shows that stirrups are loosened and that the longitudinal bars are buckled. Windows and glasses of the building were undamaged.

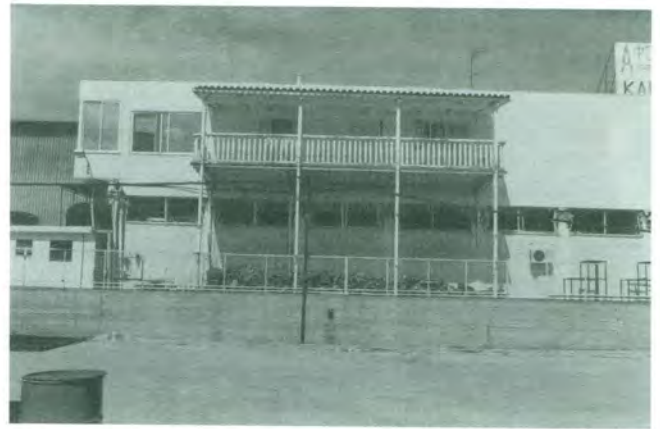
4 – Athens (1999) earthquake. Compression damage to short columns. Note the symmetrical buckling of window frames.

d) The damage represented in fig. 4 is traditionally classified as a «short column phenomenon». However, the figure shows no evidence of horizontal displacement and the interpretation leads again to consider the determinant effect of vertical actions. To this respect, it is worth noting the symmetrical buckling of the window frames.

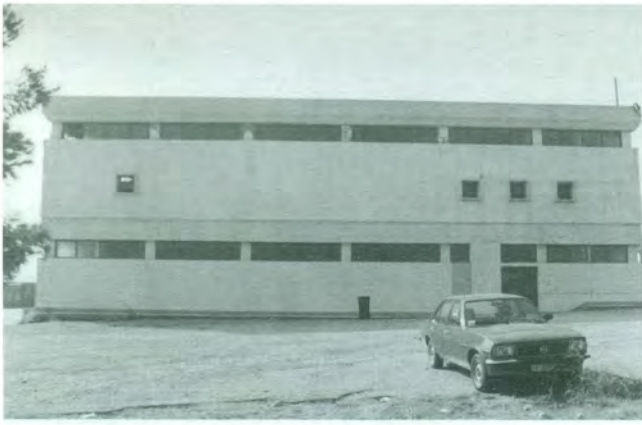
e) A similar «short column» effect was observed, after the 1999 Athens earthquake, in three blocks of two storeys industrial buildings (see fig. 5a, showing the east view of one block). Plan dimensions of each block were  $31 \times 35$  m, column sections at the ground level were  $50 \times 80$  cm, while at the upper level were  $50 \times 50$  cm, only columns at this level were damaged. At the ground floor the buildings have several brick-masonry partitions. None of the hundreds of windows glasses of the three blocks was broken during the earthquake (see figs. 5b-5c), with no evidence of important horizontal motion. Recorded damages can only be attributed to vertical action. As a matter of example, consider fig 5b, showing three short columns at the upper storey, fig. 5c, showing damage to a brickwall partition at the ground level and figs. 5d and 5e showing typical compression failures recorded in brick-masonry columns at the ground level.

5a – Athens (1999) earthquake. Compression damage to short columns. Glasses are intact. There is no evidence of lateral displacements.

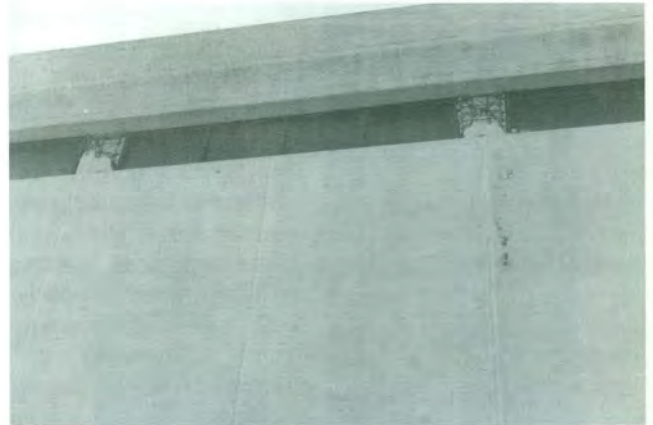
5b – Athens (1999) earthquake. Details of damage to short columns.

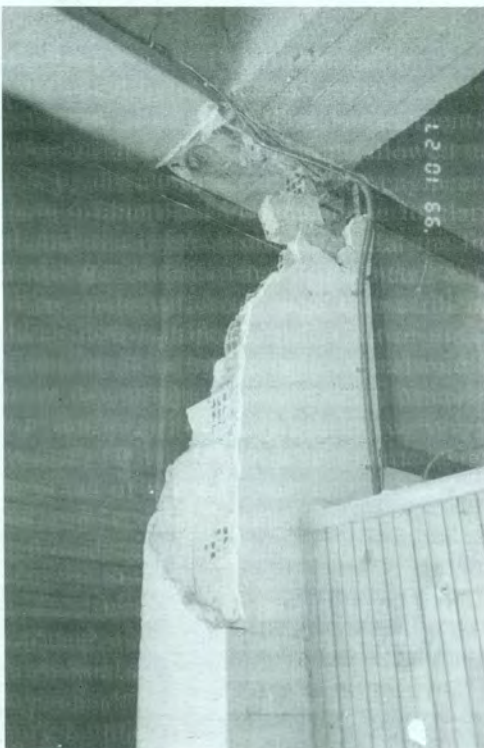
5e – Compression damage to brick masonry column. Note the unbroken window.

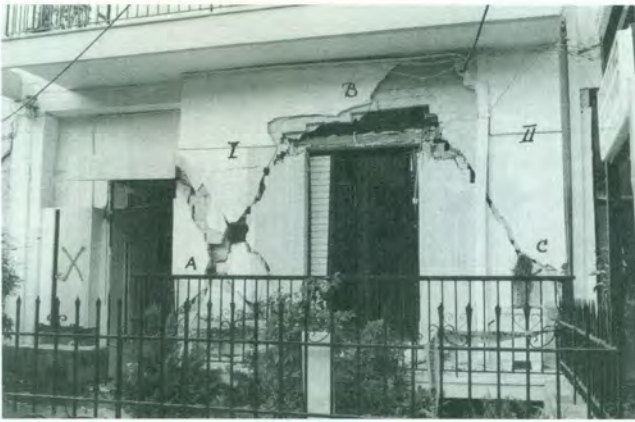
f) Figure 6a shows the heavy damage to the partitions at the ground floor of a five storeys apartment building in Athens. The load bearing system is a r.c. frame. The portion of wall above the lintel (part B of the figure) was thrown a few meters away the building, as if it were blown out by an explosion. There is a very poor evidence of lateral displacement; to this respect it should be noted that the damaged pattern in a masonry pier due to lateral actions is very similar to the one due to vertical actions, as depicted in fig. 6b. Here, damage may be reasonably attributed to the effect of vertical actions, given to the lack of significant horizontal displacements.

6a – Athens (1999) earthquake. Damage to partitions at ground level. There is a very poor evidence of lateral displacements.

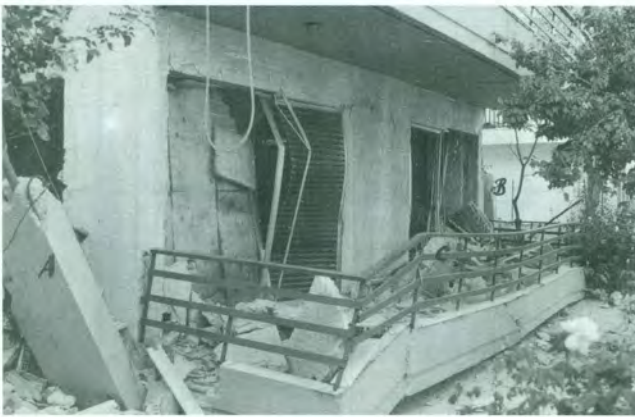
g) The vertical component is likely to be the cause of the collapse of a three storeys building, shown in fig 7. The ground floor was open and used for car parking. Its columns penetrated the floor of the first storey almost symmetrically, as seen from details A and B of the figure, and very poor evidence of lateral motion is given.

7 – Athens (1999) earthquake. Columns of the collapsed open ground floor penetrated almost symmetrically the slab of the first storey.

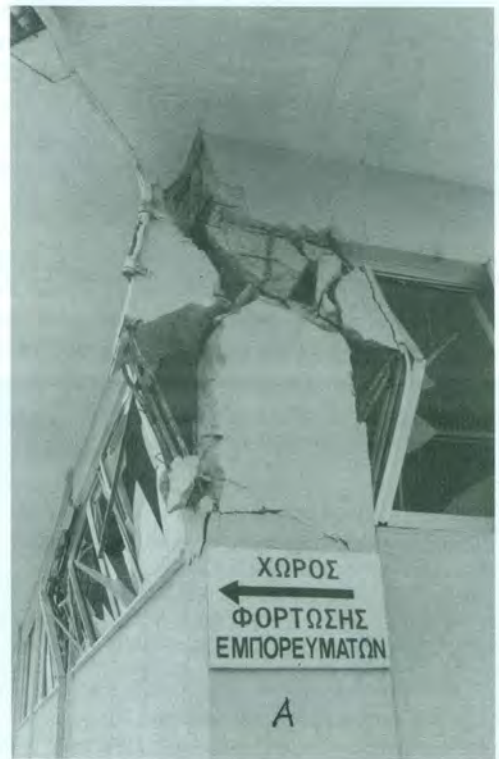
8b – Athens (1999) earthquake. Details of damage of fig. 8a.

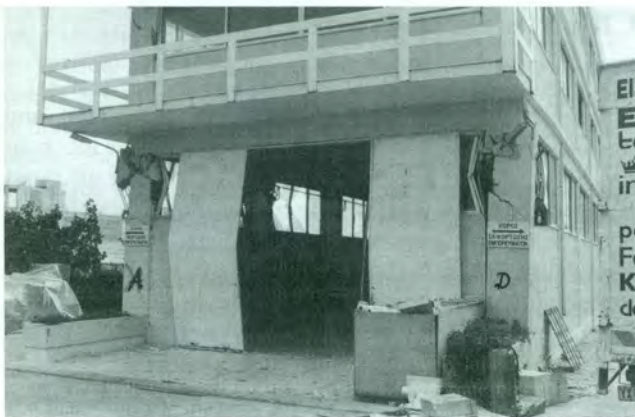
h) Figure 8a shows the quasi-symmetrical damage suffered at the ground floor of an Athens warehouse while fig. 8b shows details of the damage to the A column. The buckling of bars and the orientation of the cracks in concrete again suggest the predominant effect of the vertical component. Similar phenomena were observed in several other columns of the building, with very limited evidence of lateral motion.

8a – Athens (1999) earthquake. Compression damage at the base columns of a warehouse. Note the symmetrical buckling of bars and of window frames.

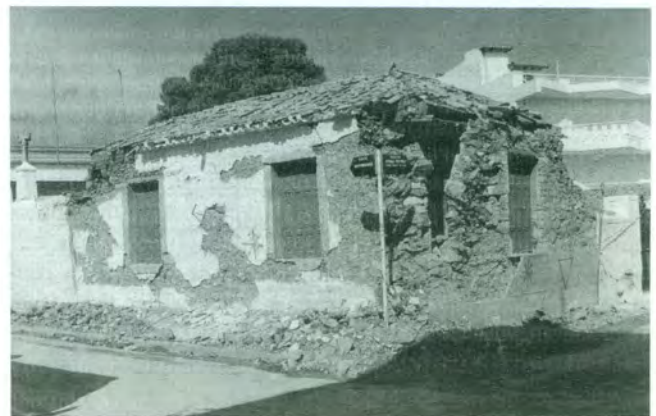
9 – Athens (1999) earthquake. Symmetrical compression damage to a masonry building.

around a vertical axis, which is typical of the effects of the vertical component, was observed in many traditional masonry buildings. As an example, figure 9 shows one of such buildings, where major damage was suffered at the corners.

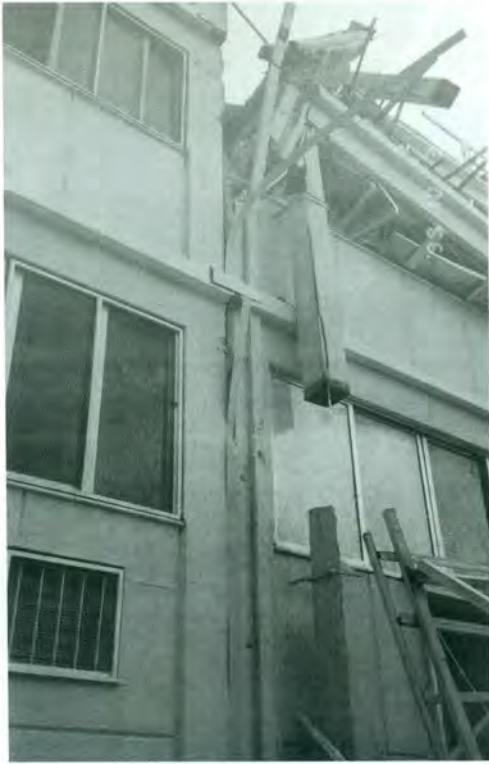
10 – Athens (1999) earthquake. Upper storey compression failure. No evidence of lateral displacements.

collapsed partially (fig. 10) or totally (fig. 11), while the remaining parts of the structure were practically undamaged. Although significant changes in the quality of construction between the collapsed and the intact portions of the buildings cannot be excluded, thus explaining their significantly different behaviour, a reasonable interpretation leads again to consider the effect of the vertical component. The intact parts of the buildings prove that they had a quite satisfactory lateral behaviour and the unbroken windows show modest horizontal actions.

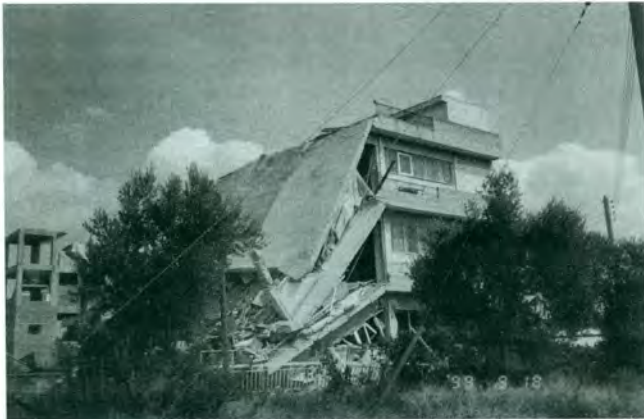
11 – Athens (1999) earthquake. Collapse of a part of a r.c. building. Note unbroken glasses of the intact portion of the building.

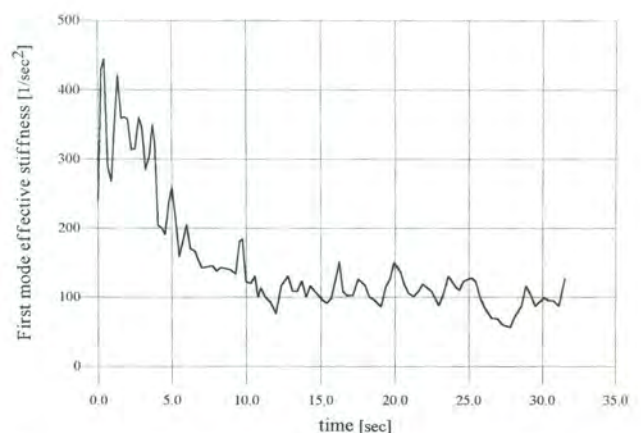
16 – Variation of the first-mode effective stiffness for building H1.

crease of about 50% the initial value (which is very close to the final stiffness value determined at the end of the previous test). This decrease cannot be attributed to lateral actions, which become significant only after  $t = 8.1$  sec. We think that it is an important effect of high frequency vertical accelerations. This effect may be greater than the one detected here, if harmonics with higher frequencies were included in the vertical input, what is likely to occur during real earthquakes. Note that this decay of stiffness occurred during a moderate earthquake. After  $t = 8.1$  sec. vertical input tends to decrease and the horizontal one to increase, thus producing a further loss of stiffness. What it is important to note is that the main part of the horizontal shock acted upon a structure whose mechanical properties were already deteriorated by the vertical action acting on the repaired systems.

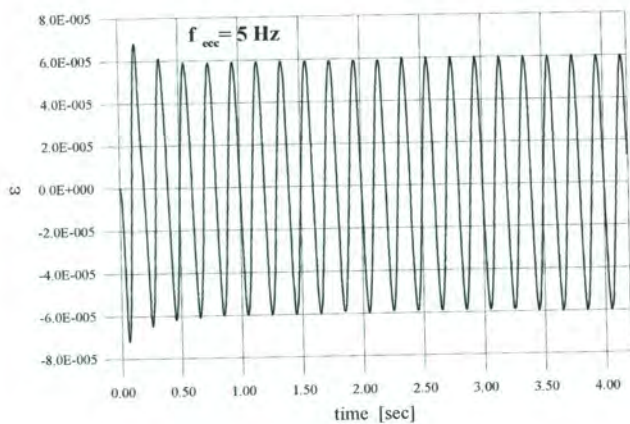
18 – Axial deformations in the central column.

19 – Axial deformations in the central column.

20 – Axial deformations in the central column.

tions but points out the danger related to the possible excitation of the first vertical mode due to the rich high frequency content of the vertical component of real earthquakes. Figures 18, 19 and 20 show the variations with time of the axial deformations determined at the section of the central column facing the first storey slab by the harmonic base inputs of frequency 5, 14 and 30 Hz ( $a_{max} = 0.1g$ ). These excitations have frequencies far from the modal ones. The graphical representation of the results concerning the 30 Hz harmonic is disturbed by the very low values of  $\epsilon$ . In all cases it is apparent the influence of the transient response. Spectral analysis shows that the frequency content of the responses has frequencies respectively of 5 and 10 Hz in the first case ( $f_{ecc} = 10$  Hz), 10 and 14 Hz in the second case ( $f_{ecc} = 14$  Hz) and 10, 16.7, 20 and 30 Hz in the third case ( $f_{ecc} = 30$  Hz). Figure 21 shows the Fourier spectrum of the response, normalized to its peak value, for the latter case. In all instances the steady state response is dominated by the frequency of the base motion but its transient part is dominated by the vertical natural modes, being the first mode predominant even when its frequency is considerably far from the one of the excitation, as it happens in the last case. Peak compression deformations occur during the first or the second period of the transient response and turn out to be respectively

1.23, 2.38 and 14.9 times the steady state values. High frequency harmonics included in a seismic input may hence excite the main vertical modes giving a contribution to the response which may be considerably higher than what expected from their actual amplitudes.
