## Dynamic behaviour of steel moment-resisting frames with a concrete slab on metal sheeting

## Comportamento dinamico di telai in acciaio a nodi rigidi con soletta collaborante in calcestruzzo

**Prof. dr. ing. Carlo A. Castiglioni, prof. dr. ing. Claudio Bernuzzi**  
Structural Engineering Department, Politecnico di Milano, Milano, Italy

**Prof. Panayotis Gr. Carydis**  
Laboratory for Earthquake Engineering, National Technical University of Athens, Greece

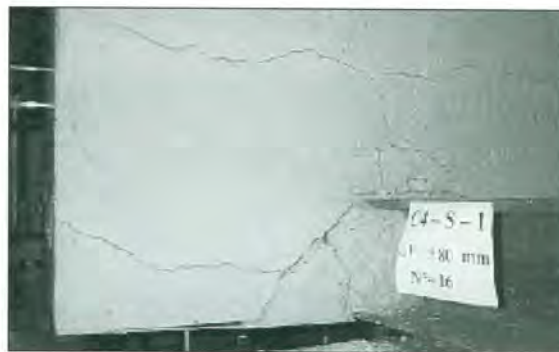
Fig. 2  
Specimen of steel  
beam-to-column  
joint with  
the concrete slab  
on metal sheeting.

The first set of specimens (named as "ns") consists of the sole steel beam-to-column connection; the second one, (identified as "s") encompassing the presence of a 100 mm r.c. slab, cast in a corrugated steel sheeting 55 mm deep (Fig. 2). The slab was connected to the steel beam only by means of three studs positioned near the free end of the beam, used only to prevent separation and detachment of the concrete slab from the beam end at the load application zone. Hence, the specimens cannot be considered as acting as

composite, but the presence of the slab is considered only in order to simulate real structural conditions and to prevent local buckling of the upper flange of the beam. Of the 6 specimens of each series, three were welded according to the C1 detail, the other three according to the C4 detail. Only 5 specimens of each series have been tested at present; the sixth one with a C4 type connection was left intact, for eventual future experimental verifications.

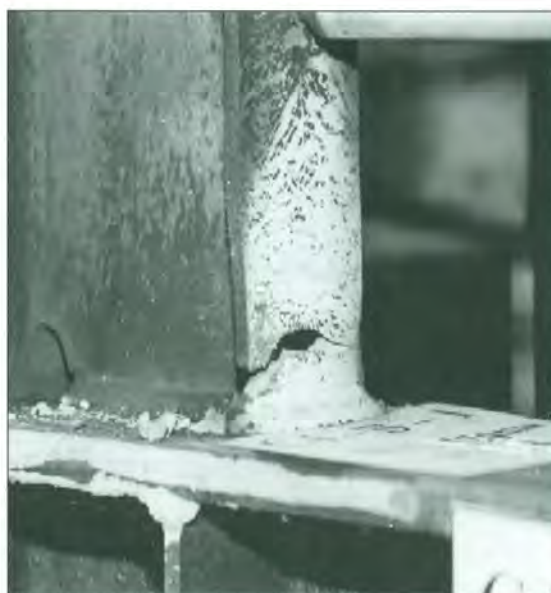
Fig. 7  
Typical  
failure mode,  
with weld  
cracking.

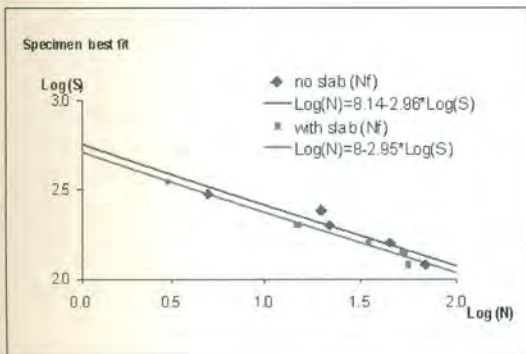
Fig. 9 Best fit S-N lines assuming  $S=\Delta v$ .

"Relative Energy Drop". The S-N lines for the specimens were obtained assuming as parameter  $S$  the displacement range  $\Delta v$  and are presented in Figures 9 and 10, which report the best fit S-N line and the design S-N curve, respectively.

It can be noticed that the low-cycle fatigue strength of the specimens with the reinforced concrete slab is lower than the one of the specimens made of the steel profiles only. Figure 11 presents, for the specimens with slab, the S-N lines obtained by assuming as  $S$  the joint rotation  $\Delta\Phi$  instead of the displacement range  $\Delta v$ . It must be noticed that changing the parameter to be assumed as  $S$  in eq. 2) a new definition of the constant  $K$  that appears in the S-N line equation is required.

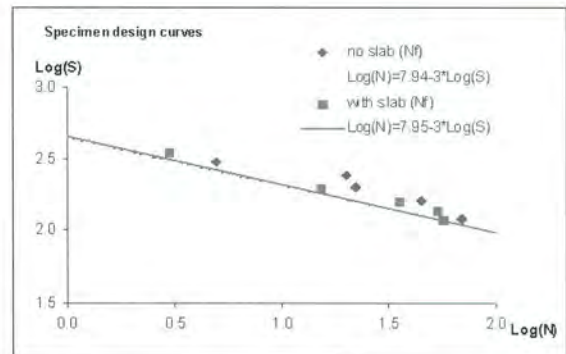
Fig. 10 Design S-N lines assuming  $S=\Delta v$ .

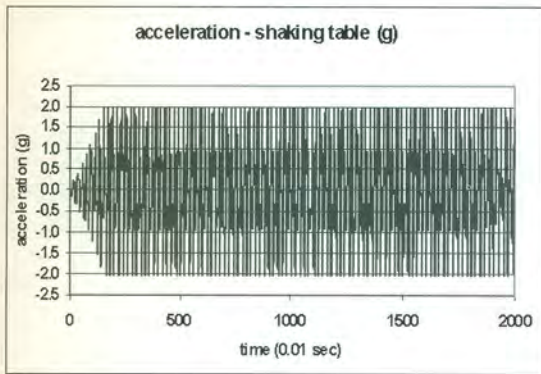
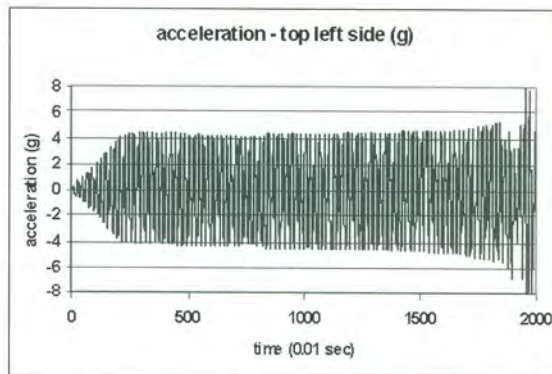
Fig. 14a  
Acceleration  
of the shaking  
table vs. time  
for specimen STF3.

Fig. 14b  
Acceleration on top  
of the r.c. slab vs.  
time for specimen  
STF3.

of the shaking table compared to that recorded on the top of the r.c. slab of the specimen (fig. 14 and 19), the relative rotations recorded between the beams and the columns at the four beam-to-column connections of the specimens and the moment-rotations diagrams for the same nodes (fig. 15-18 and 20-23). The bending moments plotted in these figures are to be considered as effective elastic bending moments and were obtained as a linear extrapolation of the values obtained by strain gauge recording in the instrumented cross sections of the beams and the columns.

It can be noticed that after nearly 18 seconds for specimen STF3 (fig. 14) and nearly 35 seconds for specimens STF4 (fig. 19), the acceleration recorded at the top of the r.c. slab begins to increase, while the input motion (i.e. the acceleration of the shaking table) remains constant. This fact indicates that some damage occurred in the structure. This is confirmed by examining the following figs. 15-18 and 20-23; these show that, corresponding to the noticed increase of the acceleration of the r.c. slab, also an increment in the relative rotation between the beams and the columns of the specimens occurs.

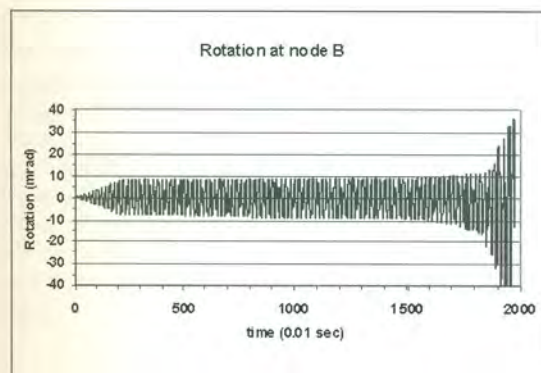
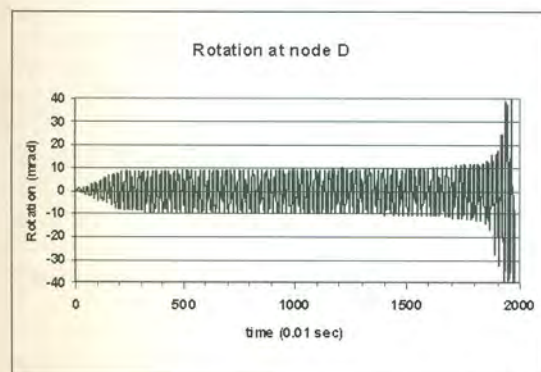
Fig. 15a  
Rotation vs. time  
at node A  
of specimen STF3.

Fig. 15b  
Moment vs. rotation  
at node A  
of specimen STF3.

Fig. 16a  
Rotation vs. time  
at node B  
of specimen STF3.

Fig. 16b  
Moment vs. rotation  
at node B  
of specimen STF3.

Fig. 17a  
Rotation vs. time  
at node C  
of specimen STF3.

Fig. 17b  
Moment vs. rotation  
at node C  
of specimen STF3.

Fig. 18a  
Rotation vs. time  
at node D  
of specimen STF3.

Fig. 18b  
Moment vs. rotation  
at node D  
of specimen STF3.

The hysteresis loops plotted in the same figures confirm that, after a phase during which the beam-to-column joints of the specimens exhibit practically a linear elastic behaviour, deterioration of both stiffness and load carrying capacity occurs, leading to complete failure of the connection.

For both specimens collapse occurred due to failure of all the four welded beam-to-column connections. Cracks always started at the lower flange of the beam and propagated upward, in some cases completely severing the beam web from the column flange. Such type of failures are similar to those reported in many MR steel frames in California during the Northridge earthquake, despite the size of the members that in this case are very small, due to the need of keeping the size of the model to an acceptable dimension for the shaking table facility.

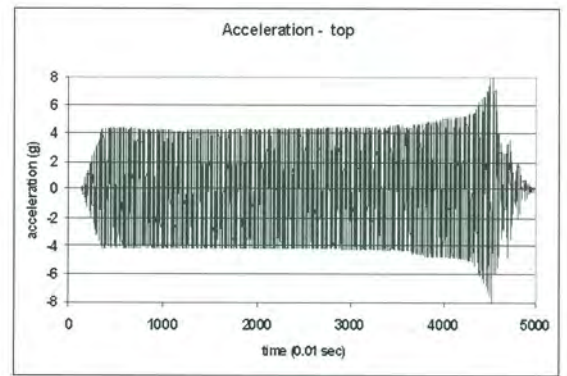
Fig. 19a  
Acceleration  
of the shaking  
table vs. time  
for specimen STF4.

Fig. 19b  
Acceleration on top  
of the r.c. slab vs.  
time for specimen  
STF4.

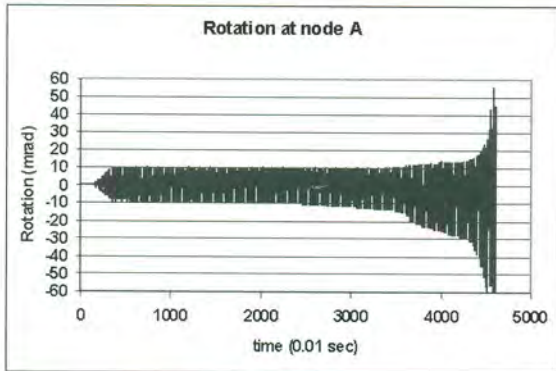
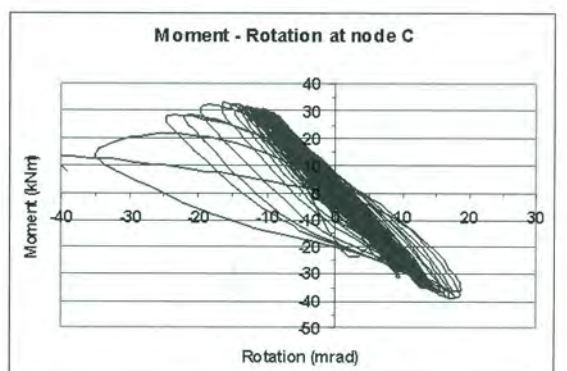
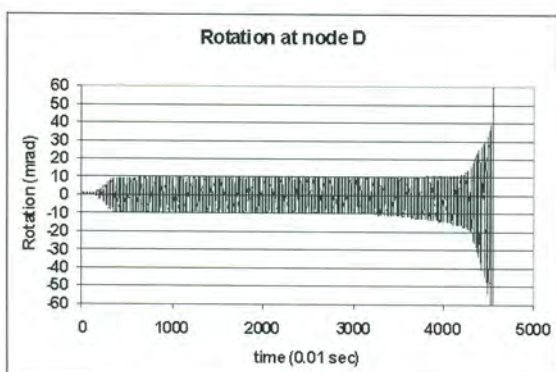
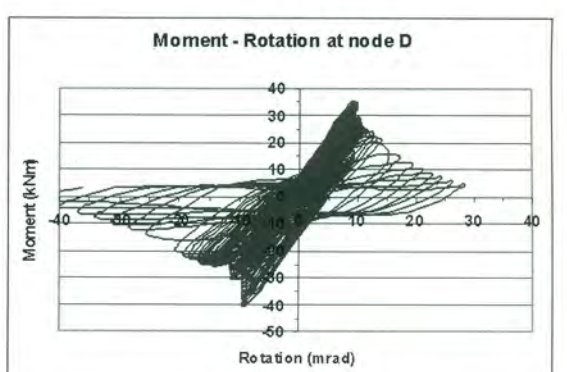
Fig. 20a  
Rotation vs. time  
at node A  
of specimen STF4.

Fig. 20b  
Moment vs. rotation  
at node A  
of specimen STF4.

Fig. 21a  
Rotation vs. time  
at node B  
of specimen STF4.

Fig. 21b  
Moment vs. rotation  
at node B  
of specimen STF4.

Fig. 22a  
Rotation vs. time  
at node C  
of specimen STF4.

Fig. 22b  
Moment vs. rotation  
at node C  
of specimen STF4.

Fig. 23a  
Rotation vs. time  
at node D  
of specimen STF4.

Fig. 23b  
Moment vs. rotation  
at node D  
of specimen STF4.

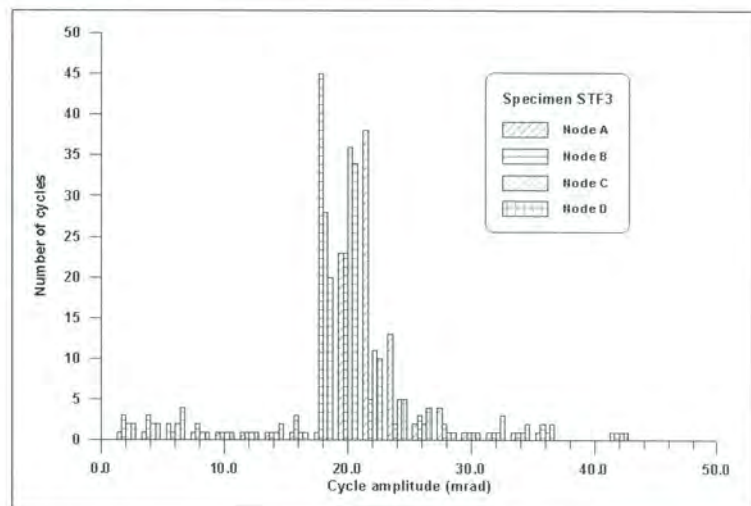
Fig. 24  
Cycle amplitudes  
at the joints  
of frame STF3.

The moment-rotation time history for each node was re-analysed by means of the Rainflow cycle counting method in order to obtain the histogram (fig. 24) giving for each cycle amplitude the number of occurrences in the joint time-history.

Of course, due to the Rainflow cycle counting procedure, it is not possible to compare the damage accumulation with the real time, because Rainflow reorders the actual cycle sequence, and produces a sequence of cycles ordered for increasing cycle amplitude, independently of the real time-history (fig. 24).

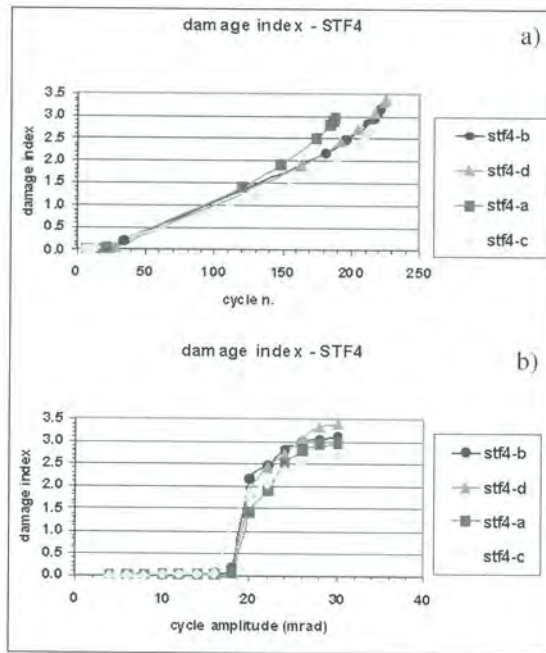
Fig. 26  
Damage  
accumulation  
process for frame  
STF4:  
a) damage index  
versus the number  
of executed cycles  
and  
b) damage index  
versus the cycle  
amplitude.

The following figs. 25 and 26 show, respectively for specimens STF3 and STF4 how the damage accumulates in the various nodes of each specimen.

Fig. 25a and fig. 26a show, respectively for specimens STF3 and STF4, how the damage index increases with the number of cycles imposed to the specimen, while figs. 25b and 26b propose the dependence of the cumulative damage index on the cycle amplitude: in fact, it is evident that cycles amplitudes smaller than 15 mrad practically leave the joints undamaged. For both specimens, it can be noticed that collapse is caused by those cycles with amplitudes ranging from 15 to 22 mrad, i.e. by those cycles having amplitudes nearly 3 to 4 times the yield rotation. It fact, it is corresponding to cycles having this amplitude that the cumulative damage index attains a value of unity.

Examining these figures, however, it can be concluded that the proposed damage assessment procedure allows a correct interpretation of the physical reality, in fact the results obtained for both specimens in terms of damage index are absolutely compatible with a definition of failure of the connection in good agreement with the experimental evidence.
