The Mw 7.1 Sept 4 2010 and Mw 6.3 Febr 22 2011, New Zealand Eqs. Comparison of EMS₁₉₉₈ and ESI₂₀₀₇ Data

SUMMARY:

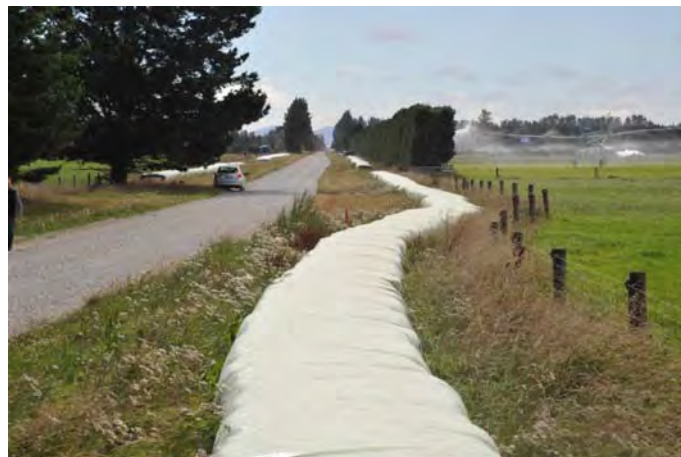
Figure 2. Horizontal displacement of approximately 5 meters caused by the Greendale fault.

The earthquake produced a surface rupture of approximately 29 km length and displacement of the order of few meters ($D_{max} = 5.3 \pm 0.5$ m and $D_{average} = 2.5 \pm 0.1$ m, Quigley et al. 2012), see Figs 1 and 2. Widespread liquefaction and lateral spreading occurred in various parts of Christchurch significantly affecting the eastern suburbs along the Avon river that meanders through the city (Avonside, Dallington, Burwood and Bexley), localized areas to the north and southwest of the city, the town of Kaiapoi and the beachside settlements near the Waimakariri River, (Allen et al. 2010). The co-seismic geodynamic phenomena are observed in an area of more than 1,000 km². The diameter of the sand volcano cone formations reached several meters in areas close to river channels and surface subsidence was measured about 1 m, often due to lateral spreading. Additionally, subsidence of the east-side on the NW-striking western segment of the fault resulted in partial diversion of the spring-fed Hororata River, (Allen et al. 2010). Based on the above data the resulting maximum intensity is estimated up to $X_{ESI-2007}$.

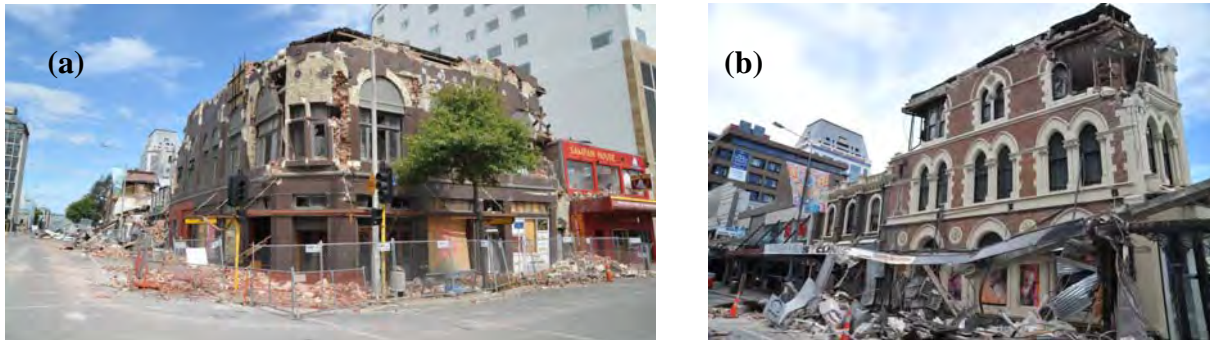
Figure 3. a) Three storeyed traditional corner building. It is an unreinforced masonry structure with higher storey heights. It is functioning as a shop in the CBD. Therefore the structure (floors and non load bearing structural members, the materials and workmanship) is strong enough. On the other hand the openings inside the building must be larger than common residential buildings. Nevertheless the facades present a robust structure. The vulnerability is estimated to be class C. The upper part and the corners of the building are damaged. It seems as if the roof had hammered over the lower part of the building. A large part of the roof collapsed. No horizontal displacements or diagonal cracks are noticeable. The observed pattern of damage is indicative of the strong vertical seismic component, a fundamental characteristic of the seismic action in epicentral regions of shallow focus earthquakes. The damage is grade 3 (substantial to heavy damage); b) Three storeyed unreinforced traditional masonry corner building. The building is functioning as a shop in CBD of the city. Each floor of the building is symmetrical along the two horizontal axes. There is also symmetry along the height. Also, it is quite well built, composing a robust structure. The plan of the building is trapezoidal having its shorter dimension perpendicularly to the facade. The stiffness along its shorter dimension is much smaller than along its facade. The vulnerability is estimated to be between class C and class D. The third storey suffered quite symmetric damage. The corner elements of the top, third, storey at the facade collapsed, while the roof is still standing up. Not any diagonal crack or any lateral displacement is noticeable. The only reason for the damage is due to the effects of the dominance of the vertical seismic motion. The damage grade is 4 (very heavy damage).

The February earthquake caused much more extensive damage to a large part of the built environment, which consists of different types of structures, due to the strong seismic shaking. Particularly, based on the guidelines of EMS_{1998} scale, (Grünthal 1998), in order to estimate the seismic intensity per different construction type, official data records (Kam et al. 2011, Data source: Christchurch City Council) were used and the following impact was observed, see Figs 3, 4 and 5.

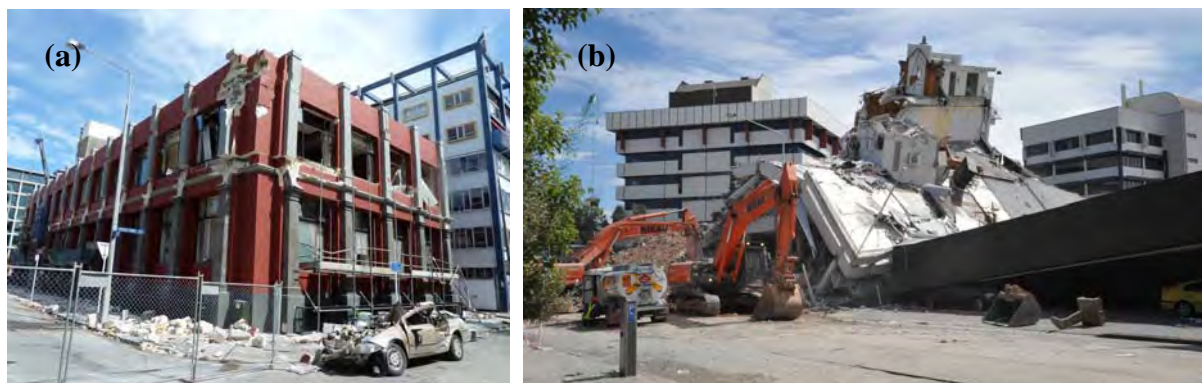
Figure 4. a) Two storeyed building with a reinforced concrete load bearing system. The ground floor is taller than the second floor. It seems to be quite robust and stiff. Its plan is orthogonal with the one dimension quite long. It seems as if it has been strengthened and probably the second storey has been added later. The

vulnerability is estimated to be of class D. The damage is concentrated in the column to beam joints of both levels and especially more in the mass of the columns and less in the mass of the beams. The elongated side of the building suffered more damage. There is not any horizontal displacement of the building nor any diagonal crack. The damage may be attributed to the strong vertical seismic component. Based on the observation that there are no damages in the column to beam joints along the short side of the building (except the one at the corner) the following point of view might be expressed: Due to the strong vertical seismic motion the framing beams of both levels vibrated vertically. The beams compose frames with the columns. These frames are functioning along the short side of the building. Due to the vertical vibration these beams functioned as levers against the joints. The damage grade is grade 2 (moderate damage); b) Multistoreyed building with a reinforced concrete load bearing system with frames. The level of earthquake resistance design and construction is of a low to moderate level. The vulnerability is estimated to be between class B and class C. The building has totally collapsed. There is no offset of the penthouse, that in despite of the total collapse maintains the same inclination of the below standing storeys. Small appendices, lightly connected to the penthouse stand intact. The building seems to have collapsed at two or three parallel and separated blocks. It is not possible to identify and assess the exact reason of the damage. Nevertheless, the non-uniform vertical loading of the structure due to multi-storey penthouse, combined with the gap along the vertical axis between the above mentioned blocks, together with the rather prevailing immobility of the penthouse, guide us to infer that besides the earthquake inefficiency of the structure a strong vertical seismic component was dominating and greatly contributed to that damage. The damage grade is 5 (destruction).

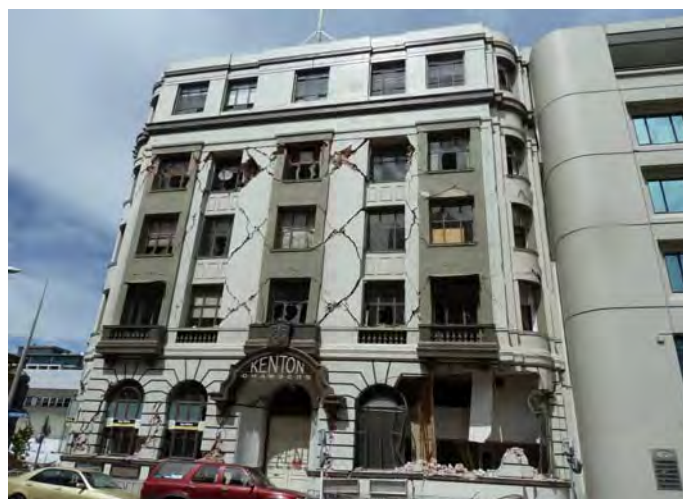
Figure 5. Five storeyed building, rather old, following traditional architecture. The last (fifth) storey looks as if it has been added after the completion of the lower four storeys. Most probably the load bearing system is reinforced concrete (slabs, beams and columns). Due to the estimated period of construction, most probably the building may be characterized as of low earthquake resistance. But due to the rather thick and strong masonry exterior wall paneling the stiffness and earthquake resistance of the whole building is increased. The vulnerability is estimated to be class C. The damage is concentrated in the first up to the fourth storeys. The fifth storey is intact. (Perhaps the added fifth storey is constructed with different materials and technology. It seems that it is stiffer than the other storeys). The heaviest damages are in the first (ground) storey and in the fourth storey. The damages give the impression as if the four storeys have been smashed. The vertical elements of the windows have been buckled. There is neither any horizontal displacement nor any diagonal cracking. The appearing diagonal cracks are due to an excess vertical loading that surpassed the strength of the vertical load bearing elements during the earthquake. The whole structure stands absolutely vertical. The whole damage might be attributed to the strong vertical seismic component that dominated the seismic action. The lack of any horizontal displacement, in despite of the almost equally strong horizontal ground motion, it is probably due to the above mentioned type of damage and due to an increase of the horizontal period of the structure. The damage grade is grade 3 (substantial to heavy damage).

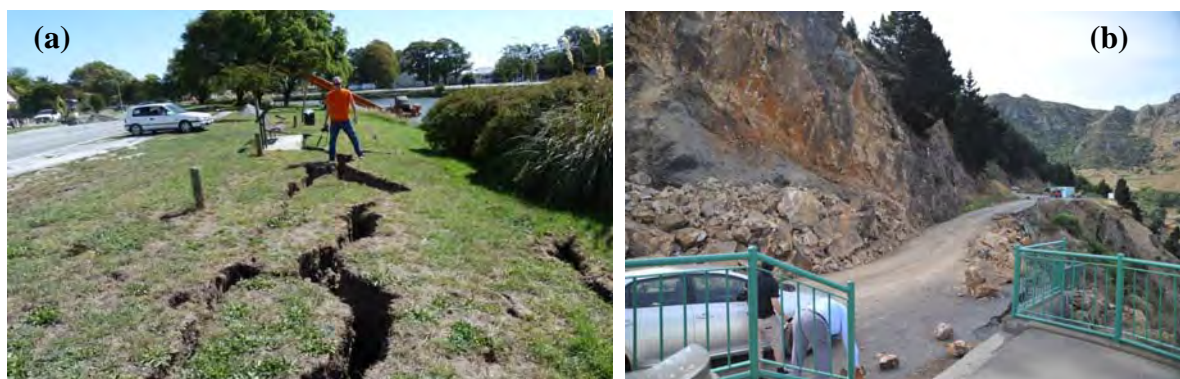
Figure 7. a) View of surface ruptures caused by the earthquake of February 22nd, 2011 in suburban area of Christchurch; b) View of co-seismic landslides triggered by the February 22nd earthquake along Sumner road, Lyttelton.

Furthermore, observed surface fissures of $> 1\text{m}$ width and up to few hundred meters length are also indicative of a maximum intensity value of $X_{\text{ESI-2007}}$, see Fig. 7a. Finally, extensive slope failures were triggered by the strong seismic shaking of the February 22 earthquake, see Fig. 7b, causing human losses and injuries, and damaging residential houses and infrastructure in RedCliffs, Mt Pleasant, Sumner, Lyttelton, Cass Bay and Rapaki areas (Hancox et al. 2011). The estimated landslide deposit volumes of the order of 10^5 m^3 and even $> 10^5\text{ m}^3$ in some locations suggest a maximum intensity value of $IX_{\text{ESI-2007}}$.
