Learning from Earthquakes

Preliminary Observations on the August 14, 2003, Lefkada Island (Western Greece) Earthquake

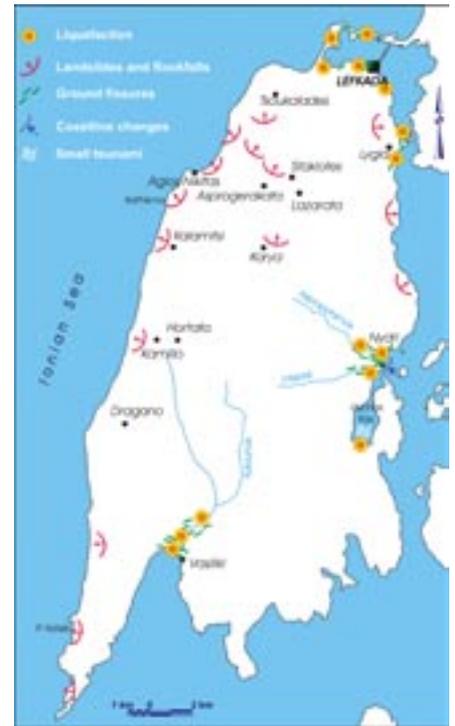
Figure 8. Geological and geotechnical effects of the Lefkada earthquake.

Damage surveys in the areas of Asprogerakata, Spanohori, Lazarata, Kavallos, Pinakohori, and Karya villages reveal building damage concentration that may be related to specific surface and subsurface topographic features. The rough

alignment of the damage coincides almost with the fault strike, a factor that may also influence the damage pattern (figure 8).

Tsunami: A very small tsunami, no more than 0.5 m, hit in Vlychos Bay south of Nydri (Figure 8) and caused minor damage to boats and coastline construction.

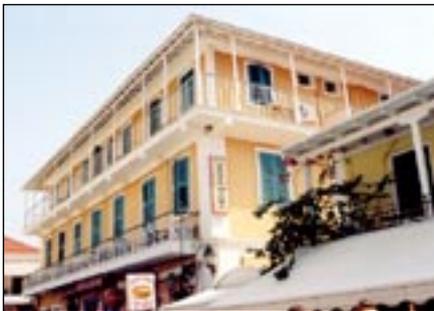
17a▲

Figures 17a, b, and c. The traditional earthquake-resistant system of Lefkada. The undamaged structure in Fig. 17a was built at the end of the 19th century. In Fig. 17b the wooden columns and beams (w) with wooden corners (c) are visible. In Fig. 17c the special earthquake system is shown under construction (NTUA-UoA team).

dual structural system (category B) behaved in a rather satisfactory way, given the intensity of the main event (ITSAK 2003). In this composite system, a wooden frame has special carved corners (figure 17) that strengthen beam-to-column joints, and wooden stiffening walls with x-braces. In the plane of these stiffening walls, various masonry materials may be added in order to increase the stiffeners and the energy absorbing capacity of the whole system. On the ground floor, the wooden frame comes in contact with the external masonry wall, with which it is well connected. The carved corners are also put in the lower part of the columns that are fixed to the foundation. In some cases, there was partial collapse of masonry walls (figure 18), but the structural stability of the building was ensured by the activation of the secondary (redundant) wood frame on the ground floor level.
