SHAKING TABLE TESTS ON 24 SIMPLE MASONRY BUILDINGS

D. BENEDETTI*¹, P. CARYDIS² AND P. PEZZOLI³

Earthquake Engng. Struct. Dyn., **27**, 67-90 (1998)

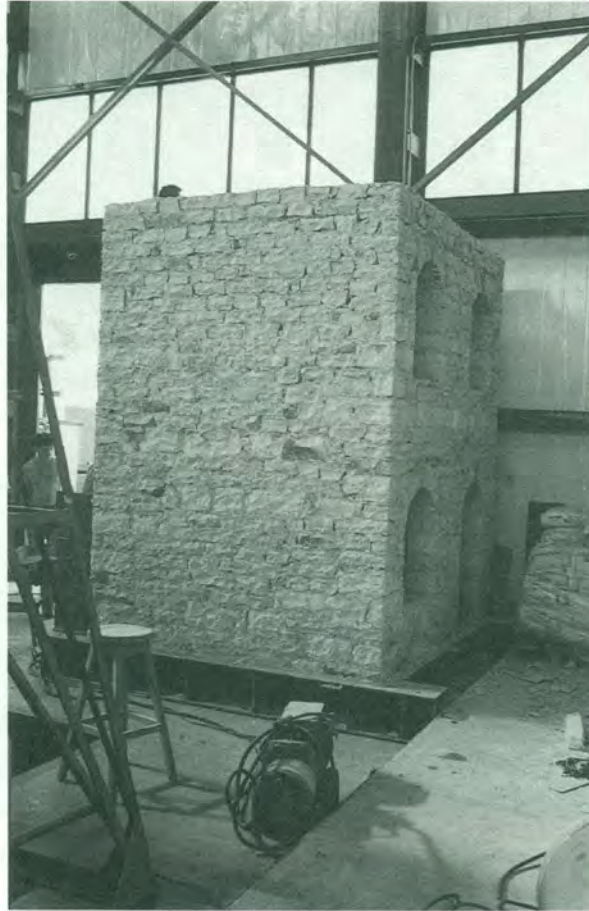
Figure 3. A building tested at LEE (stone masonry and arches)

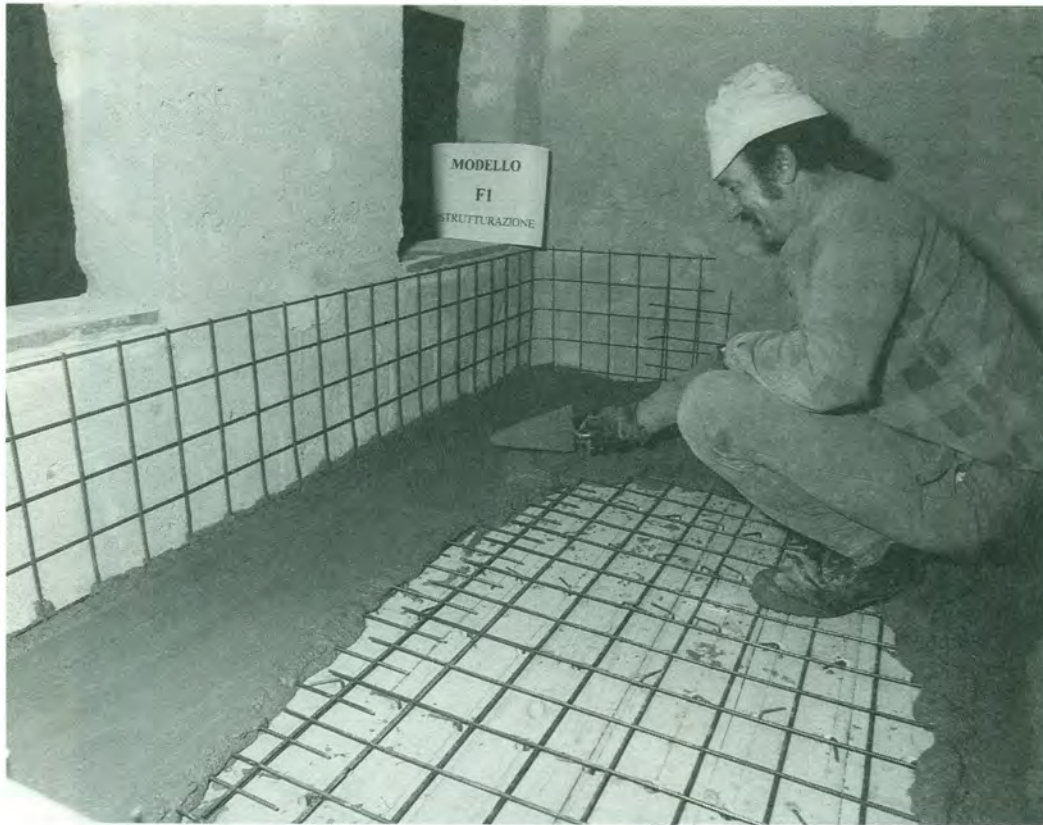
Figure 5. Steel network and cement layer over the slabs (sn)

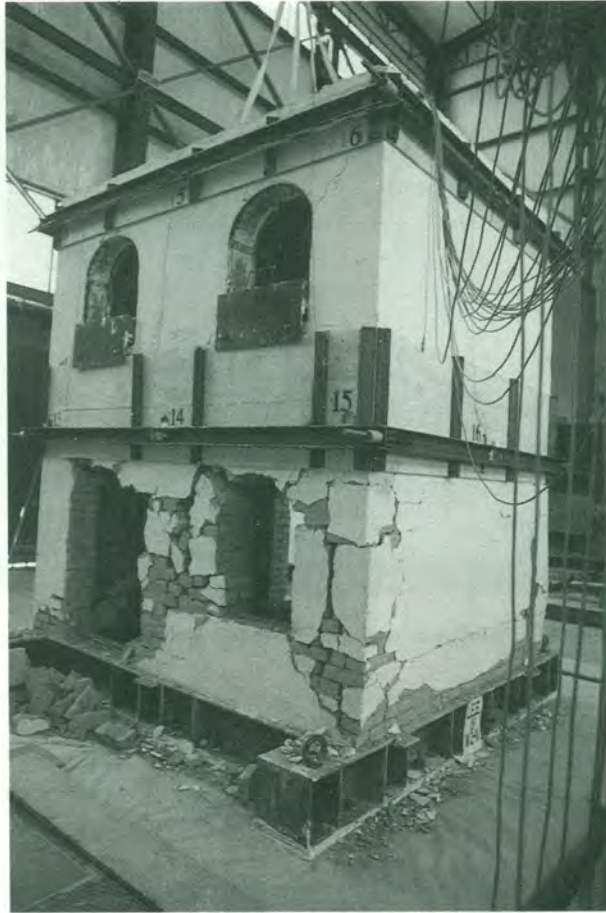
Figure 7. Building M2, strengthened by wp-ht-hb-a2, after the last shock

the number denotes the storey level whose arches are treated thus. Figure 6 shows an ISMES building strengthened by ht, Figure 7 an LEE building strengthened by ht and wp and Figure 8 an LEE building in which arches at the first storey level have been strengthened (a1); the building is also strengthened by vb and ht.

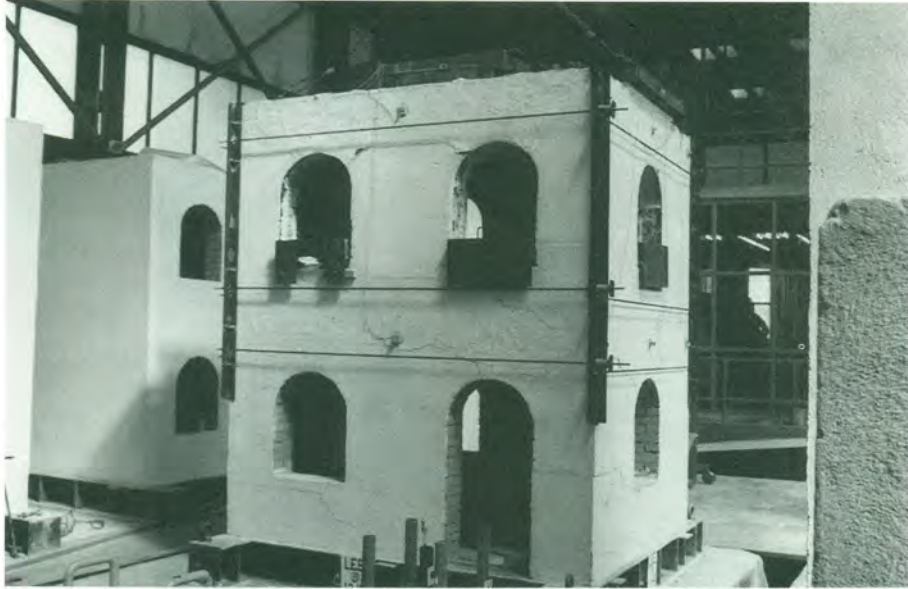
Figure 8. LEE building strengthened by vb-ht-a2, after a moderate shock

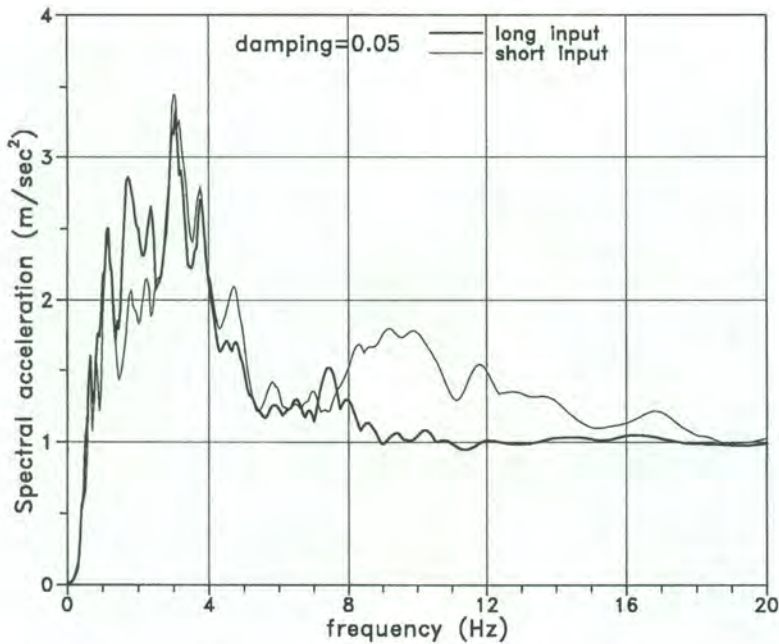
Figure 10. Acceleration response spectra (5 per cent damping) of L and S base inputs in the x-direction

These shorter excitations (label S in Tables II and III) have a frequency content similar to that of excitations L. Figure 10 shows the response spectra of the S and L base x-accelerations, normalized to their peak values. In both instances, major spectral amplifications occur for frequencies between 1 and 5 Hz, i.e. in the range of frequencies of the fundamental modes in x-direction of the tested buildings, in both their original

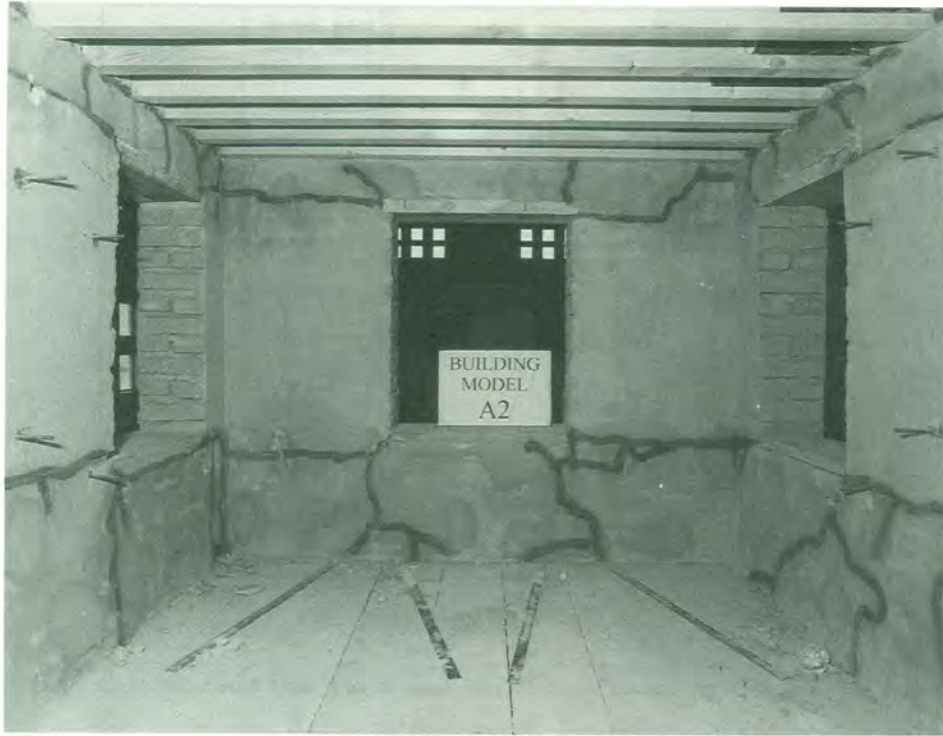
Figure 11. Heavy damage at the bases of piers at the first storey

After each test of given sequence, cracks were accurately mapped. In all original systems spandrel beams were severely affected by cracks. This suggested the implementation of repairs aimed at strengthening these parts of the structure (such as rb). In some (but not all) instances diagonal cracks were observed in piers, mainly in those at the first level. Very frequently, piers were heavily damaged at their top and bottom bases (see Figure 11) by wide horizontal cracks that almost sheared them off from the remaining wall. Wall separation occurred only in ISMES stone masonry buildings, and in one case (G1) it produced the total collapse of the building. Figure 12 shows the main stages (shots A–F) of the failure.

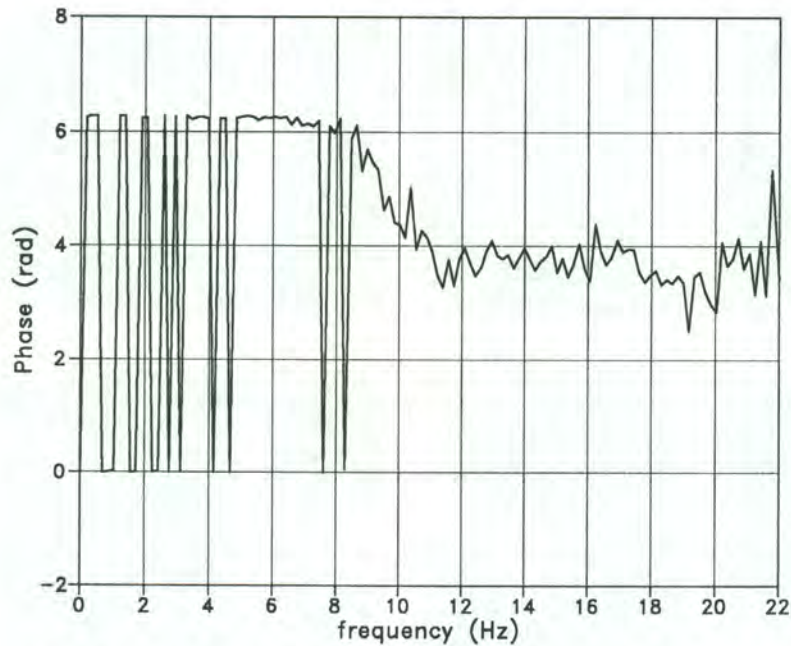
Figure 13. Phase of the cross-correlation function between points 5–8 (second level)

at the two-storey levels. Note that slabs are supported by these walls. The maximum shift (ranging from 6 up to 50 per cent for the buildings taken into account) is a measure of the independence of the out-of-plane behaviour of the two opposite walls during a given excitation. Then, the phase angle of the cross-correlation functions, evaluated by considering the signals recorded at the said pairs of points, is computed. If the two responses (at 5 and 8 or at 15 and 18) are in phase, the two opposite walls move in the same direction during the earthquake, which proves a good quality of the considered connections. As an example, Figure 13 shows the phase of the cross-correlation function computed at locations 5–8 during the last shock for the system D1. As can be seen, the two walls behave independently (phase angle $\cong 180^\circ$) for frequencies higher than 9 Hz. Note that for the repaired system D2 (lsc-ht) no independent behaviour is observed (phase function not shown here).

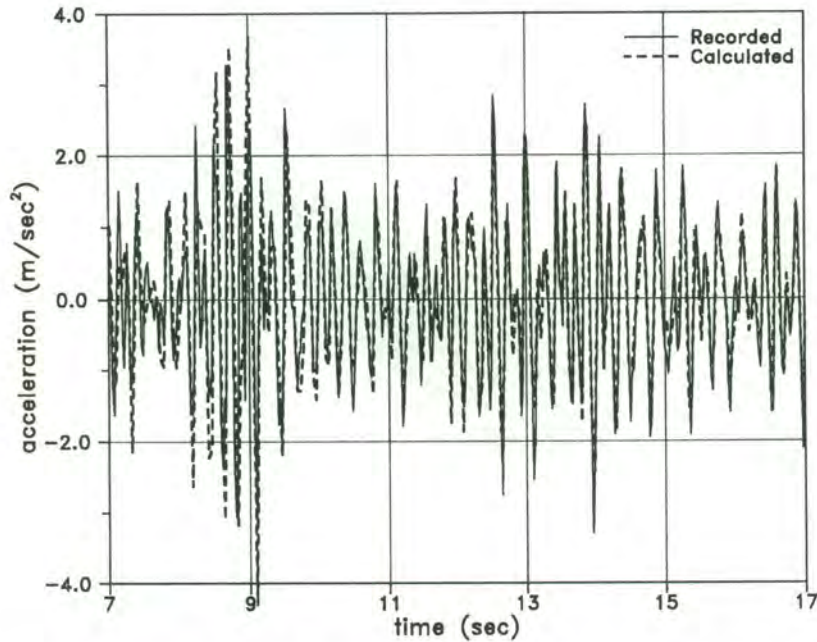
Figure 14. Calculated and recorded relative acceleration at point 2, building D1, time: 7–17 sec

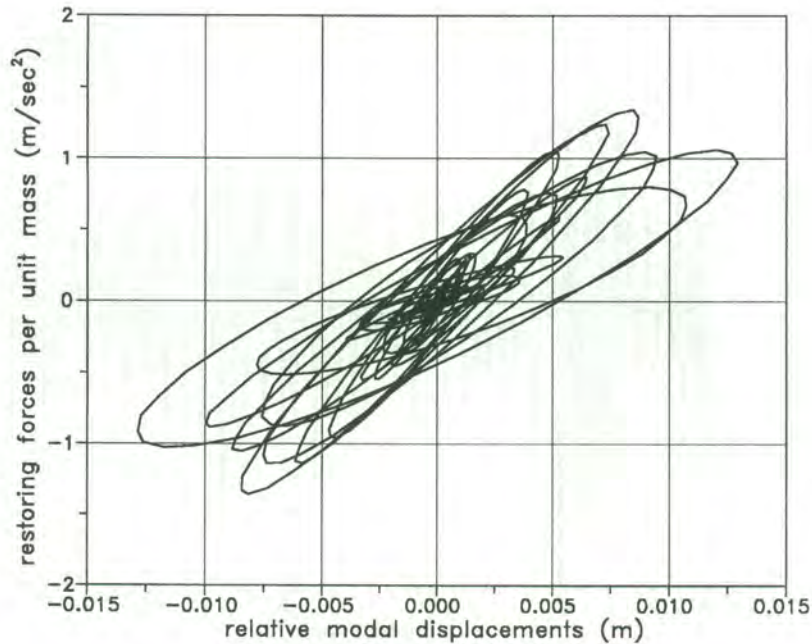
Figure 15. Restoring forces per unit mass of the first x -mode, system E1, ultimate shock

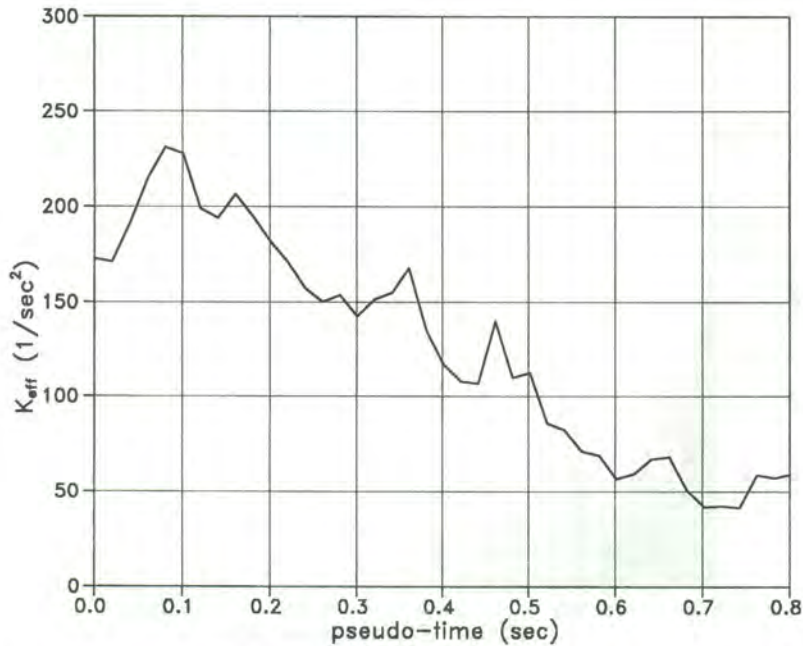
Figure 16. Variation of k_{eff} of the first x -mode during the ultimate shock, system E1

roughly considered to be proportional to the real time scale during the meaningful portion of the signal, is called pseudo-time. As an example, Figure 16 shows k_{eff} with respect to pseudo-time for the system E1 during the last shock. As can be seen, a progressive deterioration of the stiffness occurs during the response. At its end, k_{eff} is reduced to about 30 per cent of its value at the beginning of the earthquake. Note that the physical dimensions of k_{eff} are those of the square of a circular frequency ($1/\text{sec}^2$). For linear systems k_{eff} corresponds to the actual frequency of the considered mode. Here, the identified frequency of the first x -mode corresponds to the average value of k_{eff} during the whole response. In other instances, this is not the case and identified frequencies during strong shocks correspond to the values of k_{eff} during a section of the excitation. The analysis of the variation of k_{eff} helps us to understand the changes in the response mechanism during a single strong excitation or a whole set of earthquakes.

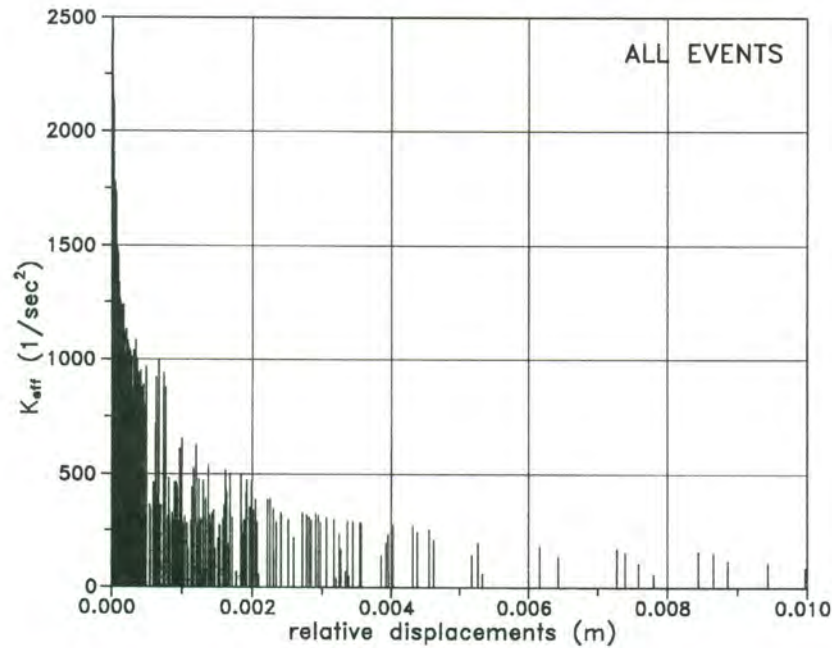
Figure 17. Lateral forces vs. displacements of the second storey for building B2, all events

Lateral forces acting on the buildings during each excitation set were computed with reference to x -direction only. They were determined by multiplying the response absolute accelerations at selected locations of y -walls by the pertinent mass. Forces are expressed as ratios to the total weight of the real building, thus expressing the base shear coefficients C during the considered base input. After integrating twice the relative acceleration in x -direction at point 2, the displacement time history is obtained. This is correlated to lateral forces, constructing the global loading–unloading cycles of the system. By considering these cycles for all the excitation sets of a given building, information about the variation of dissipation characteristics and about the change of behaviour from linear to non-linear may be easily recovered. On the basis of the cycles thus obtained, the envelope load–displacement curve can be determined, by considering all the earthquakes to which the given system was subjected. As an example, Figure 17 shows the (C -displacements) values referring to the whole set of events acting on the system B2. The envelope curve of such C values allows us to estimate the maximum base shear coefficient C_u and the one at the significant yield C_y .
